Rapid report of seismic damage and consequence analysis in the 2025 M 6.8 Dingri earthquake

Qingxue Shang^{a,b,c,*}, Zhongyi Zhou^{a,b,**}

Following the earthquake, the research group arrived at Dingri County immediately for earthquake damage assessment. This report focuses on seismic damage of local houses and buildings, and the casualty causes of this earthquake. The investigated area of this report is shown in Fig. 1 and a detailed discussion of the post-earthquake investigation results will be given in the following Sections.

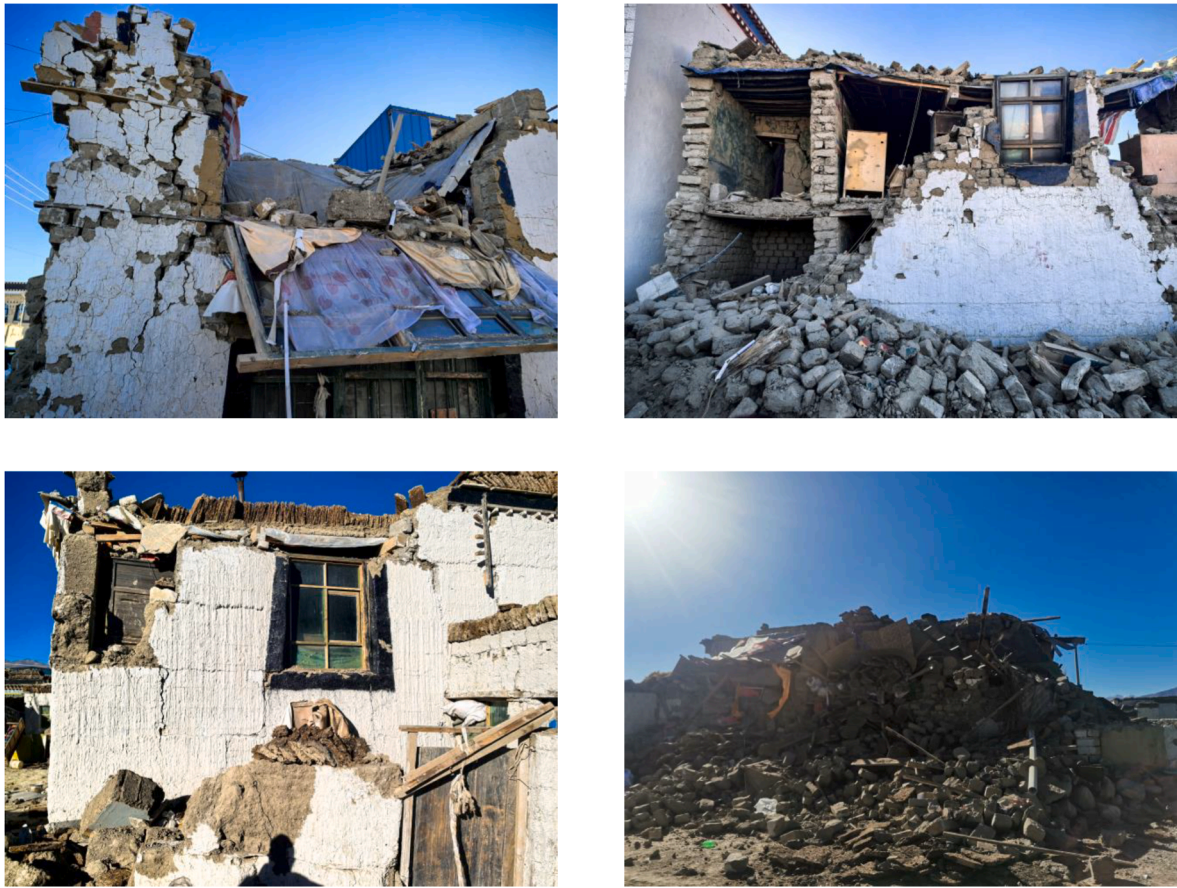
Limited by local conditions and traditional accommodation habits, rural self-built houses usually use local materials, and most self-built houses are timber structures with mud bricks or stones (Fig. 3) with poor seismic performance. During this earthquake, building collapse was concentrated in un-engineered rural houses, which is similar to the seismic damage observed in the 2022 *M* 6.8 Luding earthquake, China (Qu et al. (2023)). A large number of rural self-built houses collapsed near the epicenter. The walls of rural self-built houses are basically made of mud bricks and stones, with low strength and almost no bonding effect but large mass, which resulted in poor seismic bearing capacity. In addition, most of them have no seismic resistant measures such as ring beams and structural columns, and the mixed use of different materials and specifications (coarse stone, rubble stone, cement mortar blocks, adobe, etc) is common. There was no reliable structural connection

between the walls of different materials in the two orthogonal directions, which weakened the integrity of the houses. Most of the roofs of self-built houses were laid by wood purlin, stone, and clay. The integrity and stiffness of these roofs are usually poor, and it is difficult to effectively transmit the horizontal earthquake effect to the walls when an earthquake occurs. These self-built houses can basically maintain stability under vertical load when there is no earthquake. However, when the earthquake occurs, the ability of these houses to resist the horizontal earthquake effects is low and they are easily damaged.

Fig. 3. Seismic damage of rural self-built houses in Changsuo Town (Intensity IX area).

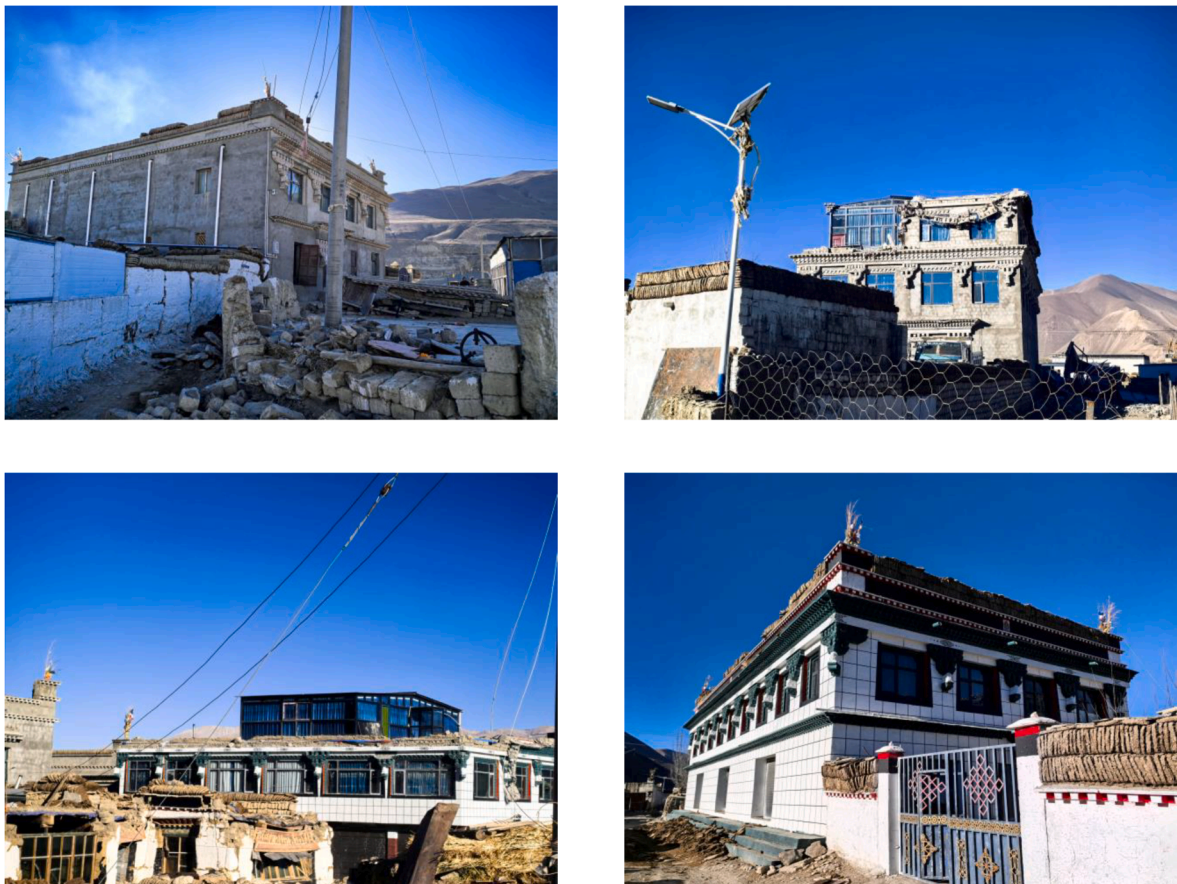
For masonry houses with efficient seismic resistant measures, the seismic performance is much better than the above discussed timber structures without seismic resistant measures. As shown in Fig. 4, the seismic performances of structural system of these masonry houses were proved acceptable during this earthquake. As we discussed with the villagers during the reconnaissance, the villagers said that the investments of these seismic resistant measures have helped them away from house loss and kept the post-earthquake safety. However, the furniture inside the houses still suffered from heavy damage, e.g., overturning of the cabinets and falling down of some dishes and home appliances from the tables. And the collapse of roof parapet walls were still commonly found in this earthquake. In addition, apart from the traditional masonry parapet walls, the roof was usually stacked with a circle of “cow dung parapets”. The sun-dried cow dungs are usually used for making fire and heating in local villagers’ daily life. It was found that most of these “cow dung parapets” falling down after earthquakes as a

Fig. 4. Seismic damage of masonry structures with efficient seismic resistant measures.

result of low connection with the structures under seismic effects. Considering the big weight of these “cow dung parapets”, there is a life-safety threat if some passengers are next to the houses during earthquakes. It is suggested to adopt some connection measures to fix these “cow dung parapets” to the roof firmly if it is necessary to posit them on the roof.

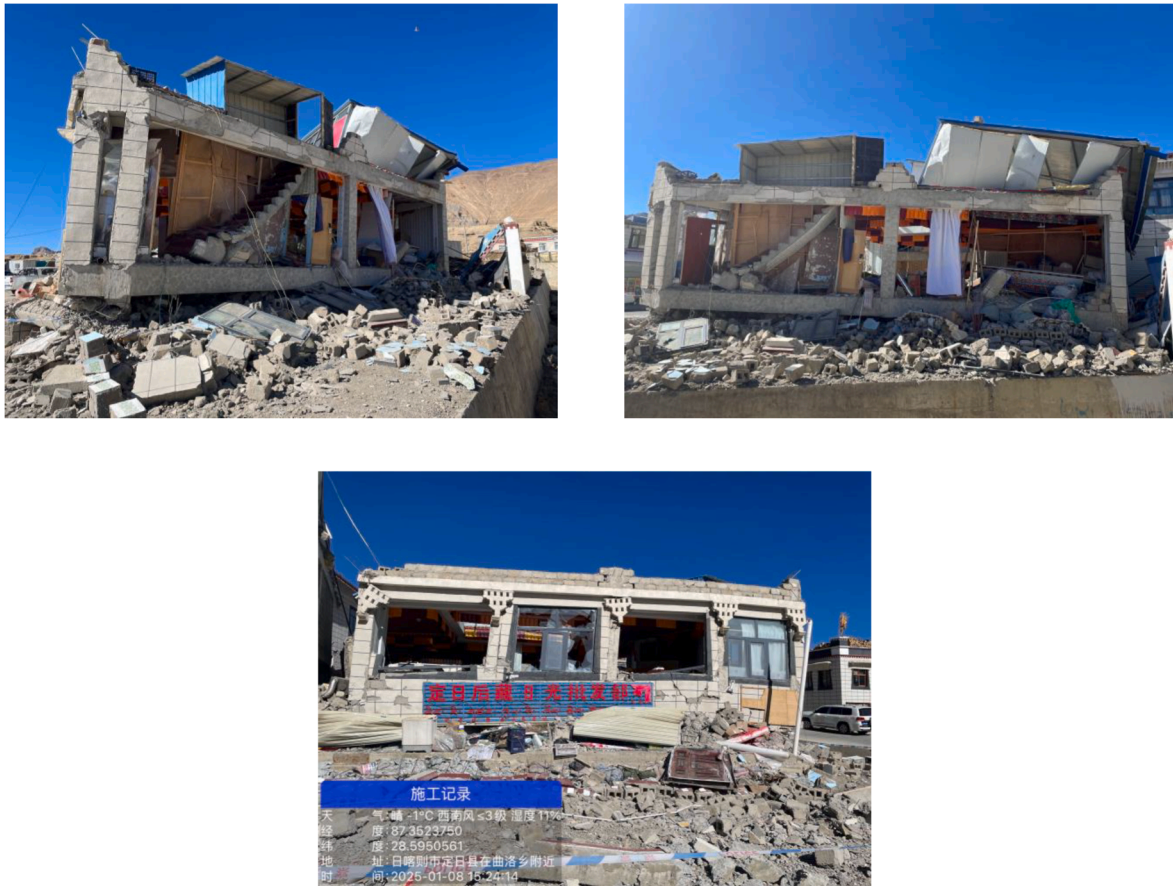
Fig. 5. Seismic damage of reinforced concrete frame houses at Quluo Town (Intensity VIII area).

A two-story reinforced concrete frame structure located at Quluo Town was found collapsed at the first story, as shown in Fig. 5. After a detailed investigation, it was found that the construction quality of this

frame structure was quite poor for the following aspects. (1) The concrete aggregates were all exposed after the earthquake. (2) The construction of the reinforcement bar was not standardized and it was found that there were no stirrups at some beam-column joints. (3) The beam section height of the first story is obviously larger than that of the column section. After check with the residents, it was confirmed that this house is self-built without seismic design. The concrete construction quality of this house was extremely poor and the anchoring, connection, lap joints of the steel bars were non-standard, which leads to the formation of a weak story at the bottom and causes the overall collapse. During the earthquake, the first story collapsed and the failure mechanisms of “strong beam-weak column” and “strong component-weak

joint” were observed, while such failure mechanisms are not permitted in seismic design code (GB 50011-2010 (2016)). Excessive deformation demands at the first story columns in the presence of weak-story mechanisms under the seismic inputs led to the collapse of this house. The top and bottom reinforcement bars of the columns were pulled out and the concrete was crushed. And significant seismic damages of the beam-column joints were found. Such seismic damage of reinforced concrete frame structures was frequently observed during past earthquakes although the seismic design codes required ductile design with “strong column-weak beam” systems to ensure the building safety (GB

50011-2010 (2016); Zhao et al. (2009)). In addition, the parapet walls at the roof all collapsed and the roof light steel frame was almost collapsed. The parapet walls, as enclosure components located at the edge of the roof in building structures, are in a special position at the top of the building. The roof accelerations of the building will be increased due to the whipping effect under earthquakes. The parapet walls are highly vulnerable to damage during earthquakes, e.g., loosening or even falling off. Especially in this earthquake affected areas, the parapet walls of houses are generally built with masonry bricks. Local yellow mud is often used as the adhesive to simply build a circle of parapet walls

around the roof. The connection between parapet walls and the main structure is usually quite weak, which results in the collapse of parapet walls, as shown in Fig. 5.

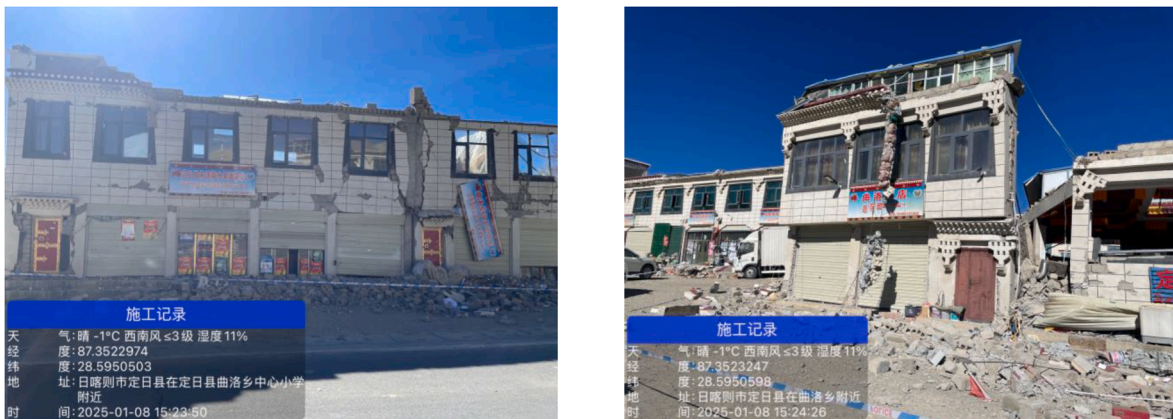
Fig. 6. Seismic damage of bottom frame structure houses.

Bottom frame structure refers to the mixed load-bearing house with frame structure at the bottom story and masonry structure at the top. Such structure system is widely used in the street facing buildings of small towns in China. This type of structure is a hybrid structure composed of two different lateral force resistance systems with varied stiffnesses in the vertical direction and is usually rigid at the top while soft at the bottom, which was reported to be easily damaged during earthquakes (Sun and Deng, 2015). Benefit from the small column spacing, there was no collapse at the first story for the investigated bottom frame structure houses. However, the second story masonry walls cracked significantly with billboards fell from walls, as shown in Fig. 6. Such seismic damage differences of the two stories were owing to the vertical stiffness difference of bottom story frame structure and second story masonry structure. In addition, the roof parapet walls were found suffered from partial or complete collapse, as shown in Fig. 6. The causes of roof parapet wall damage were the same as those discussed in Section 3.3.

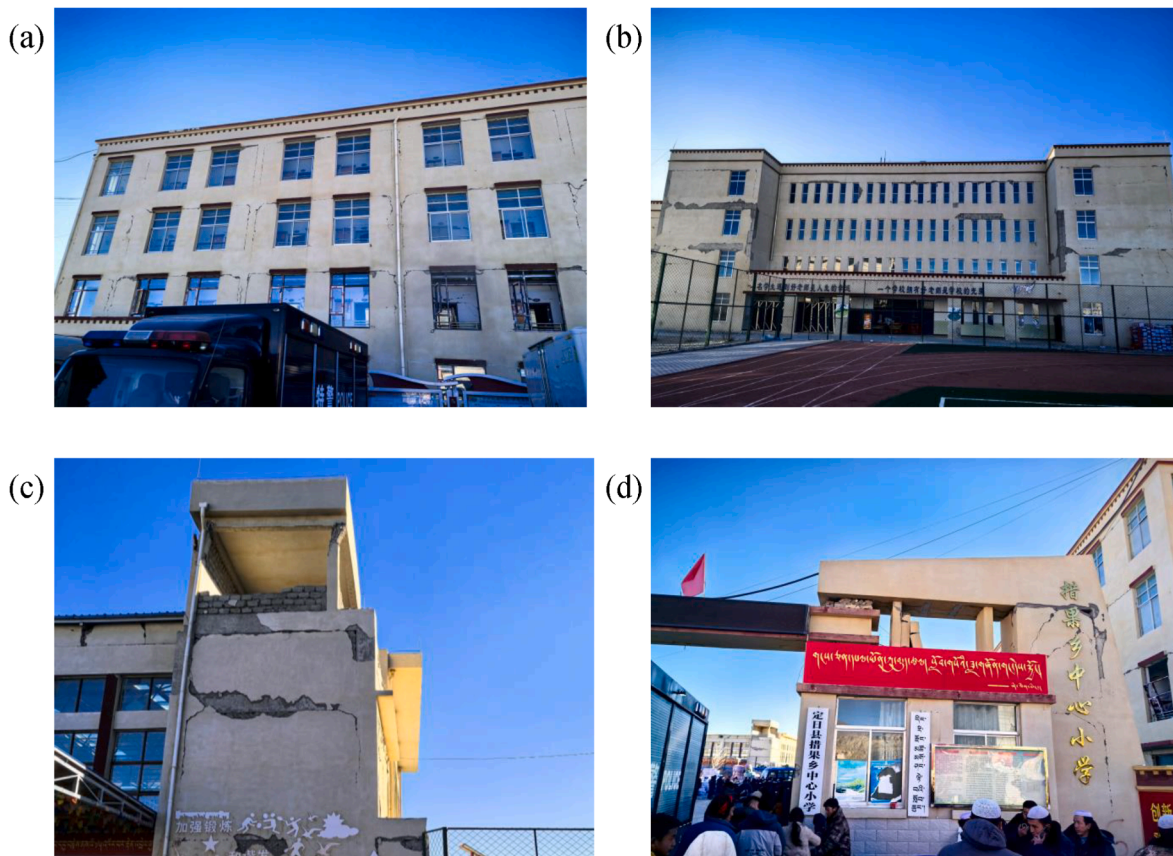
Fig. 7. Structural damages of Central Primary school in Cuoguo Town, (a) teaching building, (b) office building, (c) gymnasium, and (d) school gate.

The Central Primary School in Cuoguo Town is located in the Intensity IX area. The teaching and office buildings are all 4-story reinforced concrete frame structures with infilled walls. It was found that the main structures of these two buildings suffered slight seismic damage. The beams, columns and joints showed no obvious damage, as shown in Fig. 7a and b. However, the concrete-bent structure of the gymnasium suffered significant seismic damage to the roof due to the whipping effects. Typically, the top of the reinforced concrete column was seriously damaged. The roof infilled walls collapsed completely and several heavy cracks of the infilled walls can be observed at the lower stories, as shown in Fig. 7c. In addition, the arch over a gateway of the Central Primary School in Cuoguo Town was damaged, as shown in Fig. 7d.

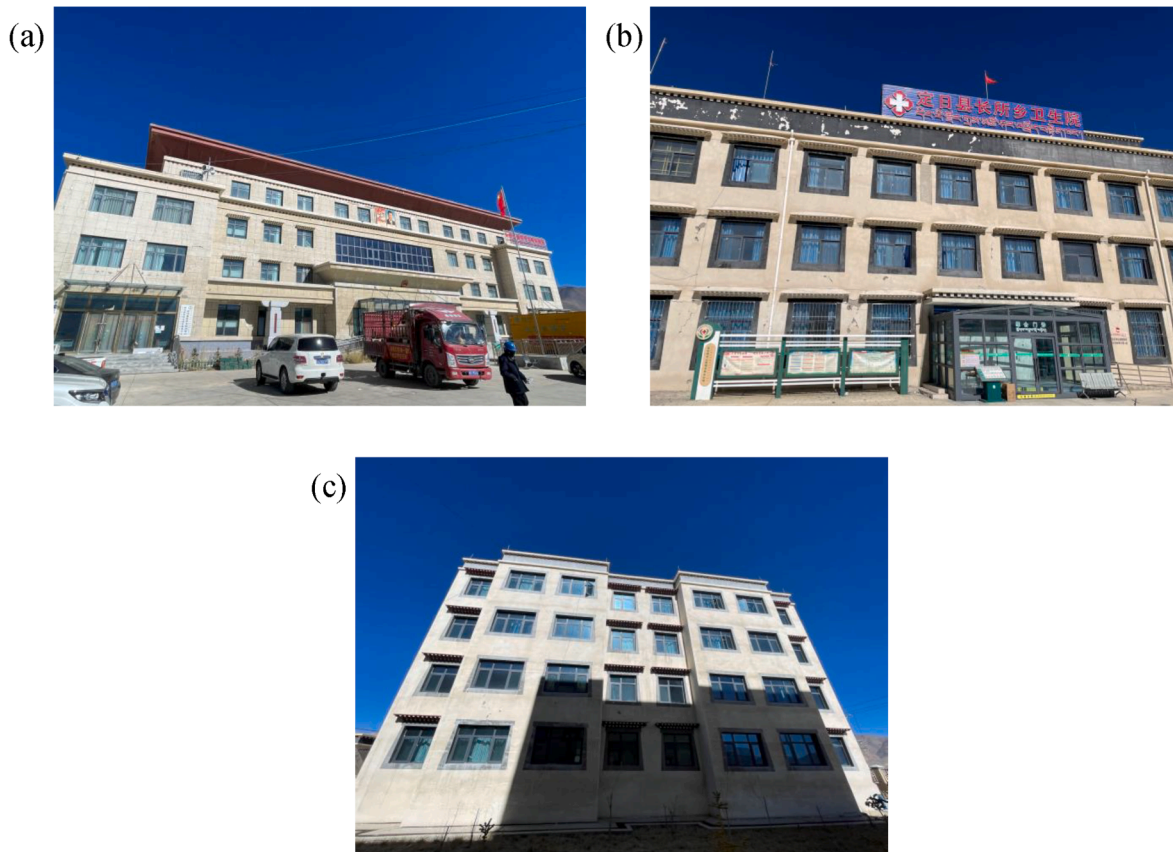
Fig. 8. Structural damages of public buildings in Changsuo Town, (a) the town government office building, (b) the health center outpatient building, and (c) the health center dormitory building.

Fig. 8 shows the structural damage of public buildings in Changsuo Town (Intensity IX area). The town government office building (four-story reinforced concrete frame), outpatient building (four-story reinforced concrete frame), and dormitory building (four-story masonry structure) of the town health center were almost undamaged from the inspection of structural components. In Quluo Town (Intensity VIII area), the structural systems of the local public buildings including the town government office building and the town government dormitory building suffered almost no damage, as shown in Fig. 9.

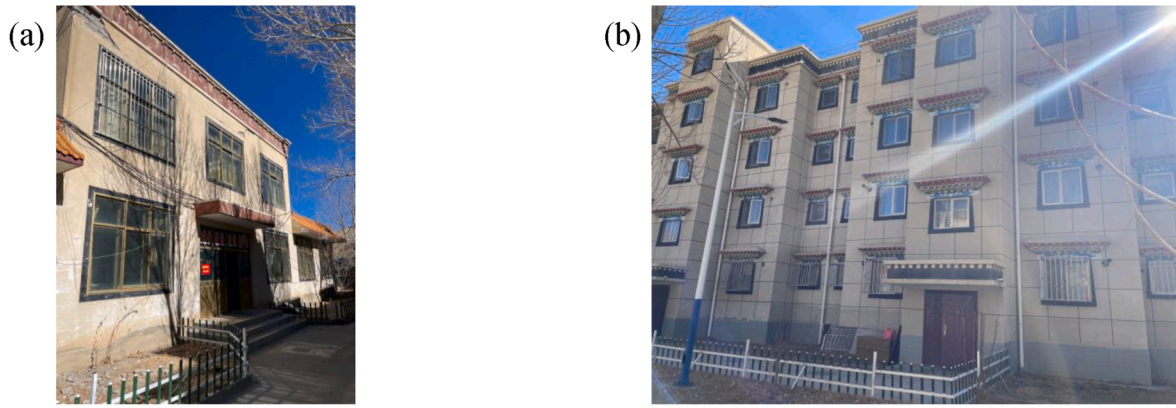
Fig. 9. Structural damages of public buildings in Quluo Town, (a) town government office building (two-story masonry structure), and (b) town government dormitory building (five-story masonry structure).

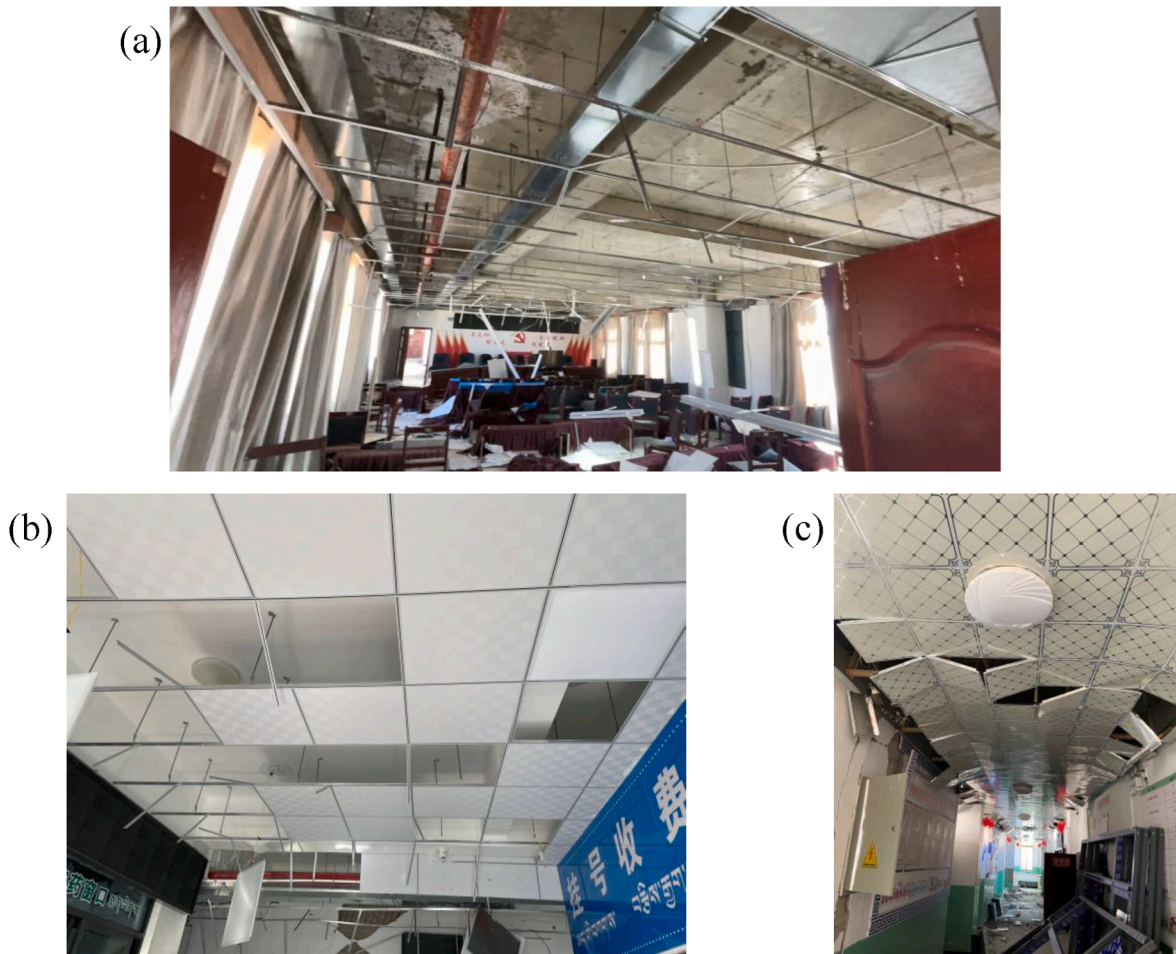
Fig. 10. Seismic damage of suspended ceiling systems, (a) government office building in Changsuo Town (Intensity IX area), (b) health clinic building in Changsuo Town (Intensity IX area), and (c) central primary school in Quluo Town (Intensity VIII area).

For the investigated public buildings, seismic damage to suspended ceiling systems are frequently observed. The seismic damages can be classified as the damage or breakage of the main tee, cross tee connections, perimeter angle, and the falling of the lay-in ceiling panels. All floors of the government office building in Changsuo Town (Intensity IX area) suffered from significant ceiling falling damage. In general, the falling percentage of ceilings increased with the increase in floor height. For the conference room on the top floor, all the ceiling panels fell after the earthquake, as shown in Fig. 10a. The main reason is that the ceiling panels were floating on the channels and perimeters, and the ceiling system was not equipped with seismic clamps and an effective seismic fastener connection. Moreover, the seismic inputs from the ground will

be amplified due to the amplification effect of the floor acceleration response of the supporting structure (Wang et al., 2021; Shang et al., 2022). Therefore, the seismic force suffered by the ceiling connections will have a higher probability of exceeding the connection bearing capacity, which caused the damage of the connections and led to a large area of ceiling panels. The falling of these ceiling panels significantly affected the functionality of public buildings, especially for hospitals and schools with a large number of patients and students, as shown in Fig. 10b and c. The falling of these ceiling panels may also impact people passing through during the earthquake. It should also be noted that different types of suspended ceiling systems all suffered from heavy seismic damage (Fig. 10b and c) during this earthquake. Similar seismic damages of suspended ceiling systems were also reported in the 2013 M 7.0 Lushan earthquake, China (Wang et al., 2016).

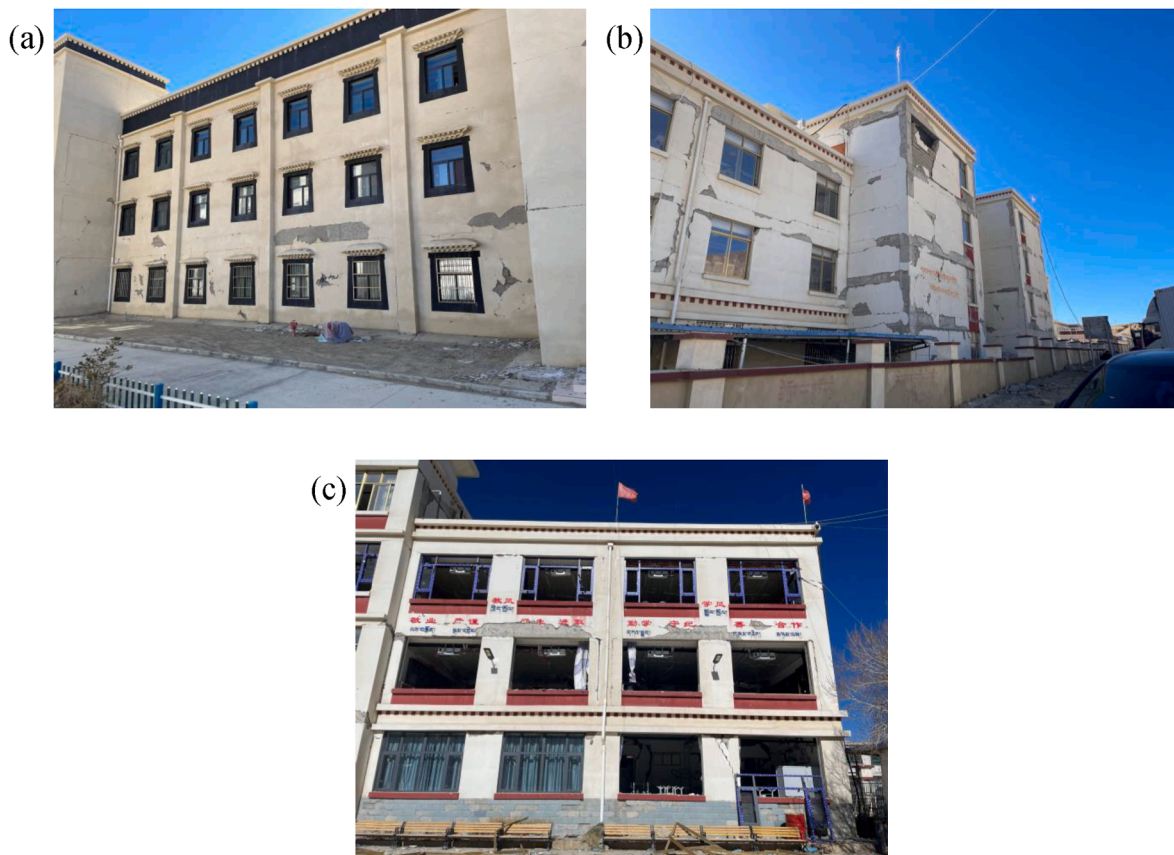
Fig. 11. Seismic damages of exterior facade walls, (a) health center outpatient building in Changsuo Town, (b) central primary school #1 teaching building of Quluo Town, and (c) central primary school #2 teaching building of Quluo Town.

The exterior facade walls of public buildings were found to be easily damaged in this earthquake. Both horizontal and vertical cracks were found at the exterior facade walls of the teaching building and office building of the Central Primary school in Cuoguo Town, as shown in Fig. 7a and b. Most of the cracks were found at the connection of the walls and beams, or columns of the structures, especially at the wall positions next to windows. Cracks or even falling off were found at various positions of the plaster skin coats on the exterior facade walls, mainly due to the disharmony of deformation between the surface and the main structure. The shear failure of the bonding interface occurred under a small inter-story drift ratio. Similar cracks of exterior facade walls were also observed at public buildings in Changsuo Town and Quluo Town, as shown in Fig. 11. It should be noted that out of plane

damage and partial collapse of the top floor exterior facade wall were observed at central primary school teaching building of Quluo Town (Fig. 11b). Such damage was also found at the roof exterior facade walls of gymnasium building at the Central Primary school in Cuoguo Town, which suffered serious overall collapse under the amplified acceleration responses at the top of the structure, as presented in Fig. 7c.

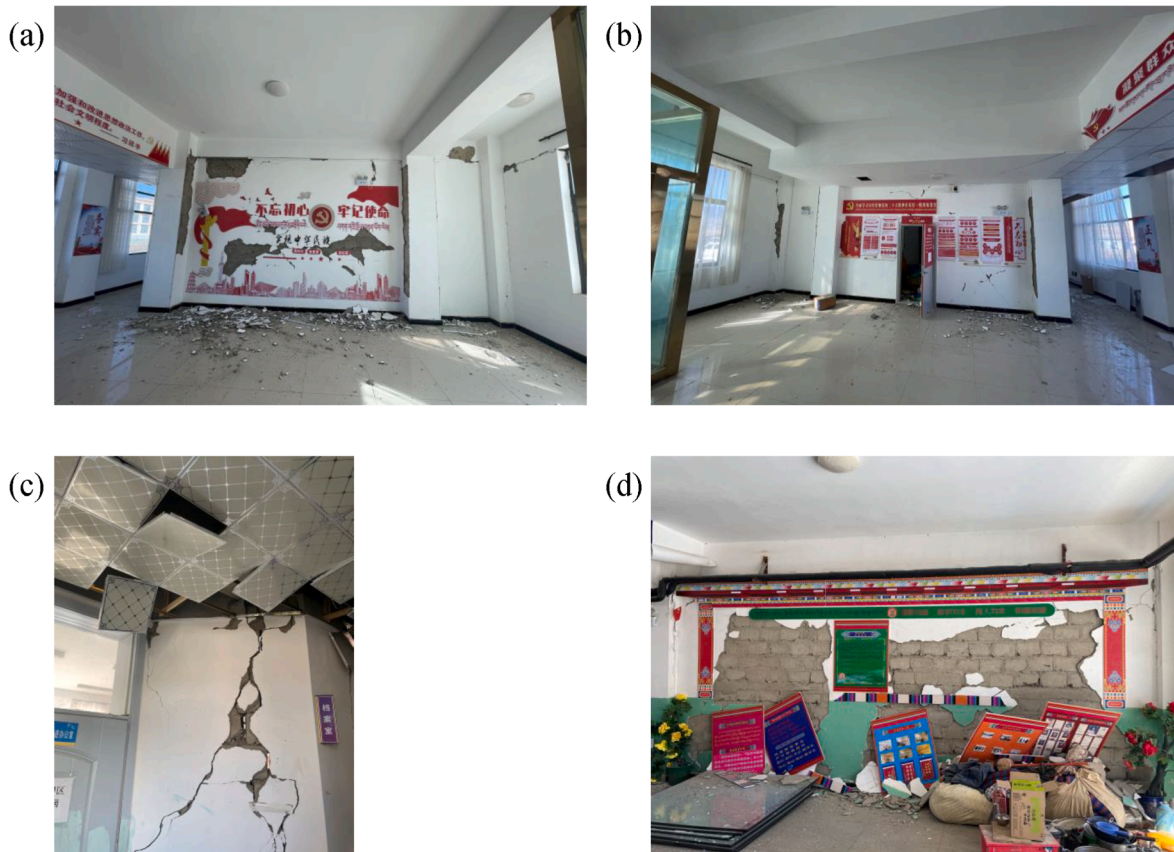
Fig. 12. Seismic damages of infilled walls, (a) spalling of plaster of infilled wall at town government office building in Changsuo Town, (b) shear cracks of infilled wall at town government office building in Changsuo Town, (c) shear cracks of infilled wall at central primary school #1 teaching building of Quluo Town, and (d) spalling of plaster at central primary school #1 teaching building of Quluo Town.

The seismic damages of infilled walls are commonly observed in earthquakes. The observed damage types in this earthquake include horizontal and vertical cracks that occur at the interface between the infilled walls and the structural beams or columns, shear cracks at the walls and wall limbs at the door and window openings, spalling of plaster and falling bricks. The observed damage examples of infilled walls were given in Fig. 12. According to previous earthquake damage investigation experience and quasi-static test results of frame structures with masonry filled walls, cracks of masonry infilled walls usually first appear at the junction of the infilled walls and frame beam or column components, and shear cracks will appear when the deformation increases. The laboratory test results from Xie et al. (2022) indicated that the initiation of small cracks in masonry, mainly concentrated in bed and head joints in plaster or along the interfaces with the columns and/or the top beam of the frame will occur under a low later drift ratio of 0.068% with a probability of 50%. The observed damages of infilled walls can confirm that the lateral deformation of the buildings in this earthquake is not too large, which also explained that why the main structure systems are usually basically undamaged.

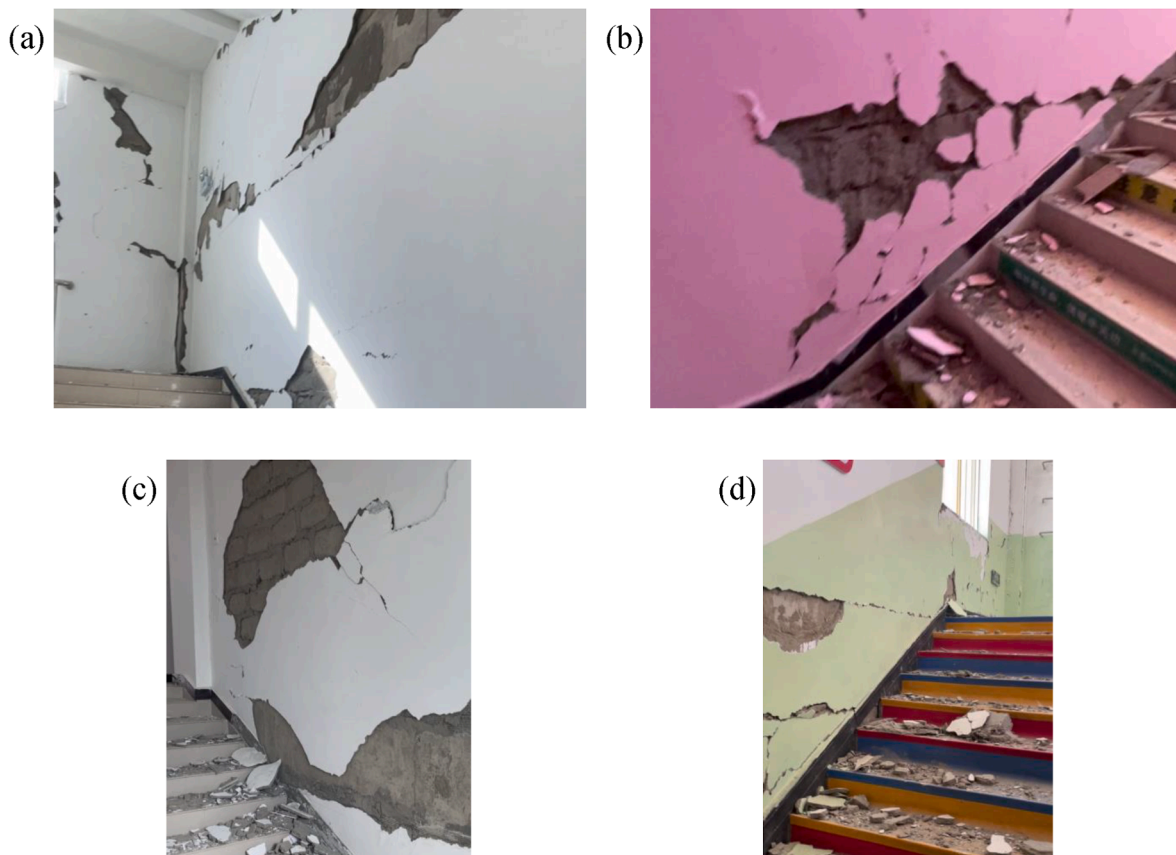
The seismic damage phenomenons of stairwell walls are similar to those observed for the infilled walls mentioned above, as shown in Fig. 13. The reason for serious cracks of the stairwell walls is that the

inclined plate and inclined beam of the stair segment increased its horizontal stiffness, which results in greater seismic force distributed to the stair. And the stairwell wall is relatively high and has no floor slab support. In addition, the stair treads embedded in the wall further weaken the wall section. It is worth noting that the spalling of plaster and falling bricks of the stairwell walls and infilled walls seriously blocked the passage of the route of emergency escape, which may get the passengers injured.

Fig. 13. Seismic damages of stairwell walls, (a) town government office building in Changsuo Town, (b) health center outpatient building in Changsuo Town, (c) town government office building of Quluo Town, and (d) central primary school #1 teaching building of Quluo Town.

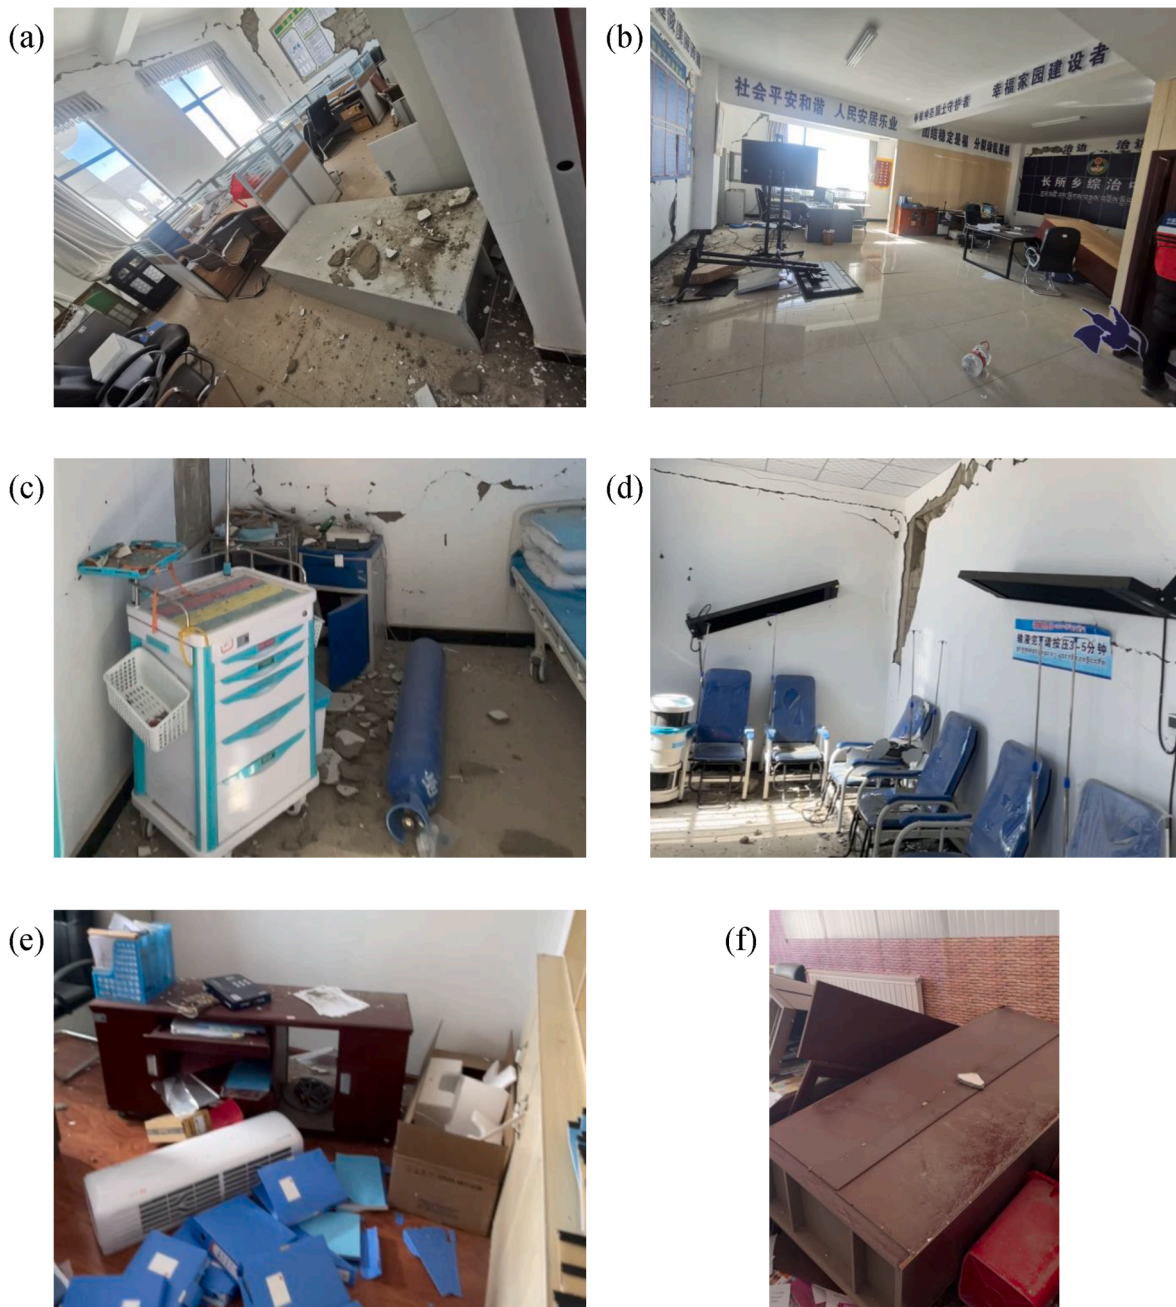
Seismic damage to the inside contents was predominated by the sliding and overturning of cabinets, projector displays, medical carts, and oxygen tanks, and falling of indoor air conditioner units, as shown in Fig. 14. The cabinets, projector displays, medical carts, and oxygen tanks are usually free-standing on the floors without any anchor measures for seismic protection. Based on the shaking table test data from Shang et al. (2023), the median overturning peak floor acceleration (PFA) is 0.366 g for hospital cabinets located on ceramic tile flooring. A rigid block analysis of single window freestanding hospital cabinets by Di Sarno et al. (2019) indicated that the median overturning PFA is 0.38 g, as shown in the seismic fragility curves in Fig. 15. The overturning of these inside contents is mainly due to the fact that they were not anchored to the floor or the wall. The large aspect ratio resulted in a high center of gravity, which aggregated the seismic risk. In addition, the investigation results indicated that for higher floors in a building, the overturning of inside contents became heavier due to the amplified floor acceleration responses, which are the seismic inputs of these contents. Considering the large magnitude of this earthquake and the floor amplification effects, the seismic inputs of these contents may exceed the overturning limitation and therefore resulted in the seismic damage presented in Fig. 14. Apart from the overturning damage, the failure of wall-mounted monitors (Fig. 14d) and air conditioner unit (Fig. 14e)

Fig. 14. Seismic damages of inside contents, (a) overturning of cabinet at town government office building in Changsuo Town, (b) overturning of projector displayer at town government office building in Changsuo Town, (c) overturning of oxygen tank and sliding of medical cart at health center outpatient building in Changsuo Town, (d) almost falling monitors at health center outpatient building in Changsuo Town, (e) falling of wall-mounted air conditioner unit and cabinet contents, and (f) overturning of cabinets at central primary school #1 teaching building of Quluo Town.

were also observed. The falling down of such equipment may also threaten the life safety of surrounding passengers.
