Development characteristics and formation analysis of the Liangjia Village earth fissure in the Weihe Basin, China

Abstract Liangjia Village earth fissure, one of the 79 earth fissures along the Kouzhen–Guanshan fault located in the northern Weihe Basin, causes severe damage to buildings and farmlands. Since the late 1950s, 40 earth fissures have occurred in a similar east–west (EW) direction parallel to the Kouzhen–Guanshan fault, and a further 39 earth fissures have occurred with north–west, east–north, or north–east orientations intersecting the fault. In this study, a case study of Liangjia Village earth fissure was conducted to investigate the mechanisms of fissure generation in detail. Geotechnical and geophysical methods including measurements, trenching, drilling, and seismic exploration were used to reveal the basic characteristics, geological background, and origin model of the Liangjia Village earth fissure. This earth fissure, with a total length of 800 m in 2014, runs EW parallel to the Kouzhen–Guanshan fault, and it has damaged buildings and farmlands by forming sinkholes, gullies, subsidence, and a scarp. The trenching results indicated that this fissure underwent m

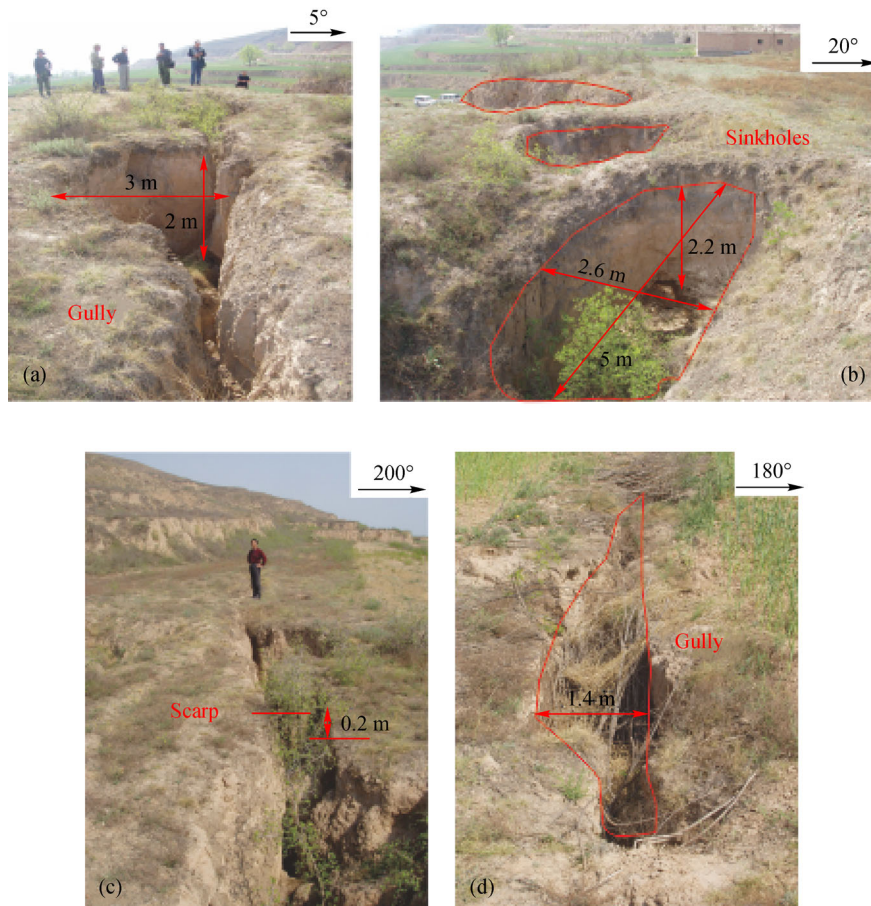
during a field survey showed that this fissure has caused sinkholes (Fig. 4(b)), a scarp (Fig. 4(c)), gullies (Figs. 4(a) and 4(d)), and subsidence at the earth's surface. The sinkholes caused by the earth fissure have a maximum visible length, depth, and width of 6, 2.6 and 2.2 m, respectively.

**Fig. 4** Damage related to Liangjia ground fissures. (a)&(d) Gullies, (b) sinkholes, (c) scarp.

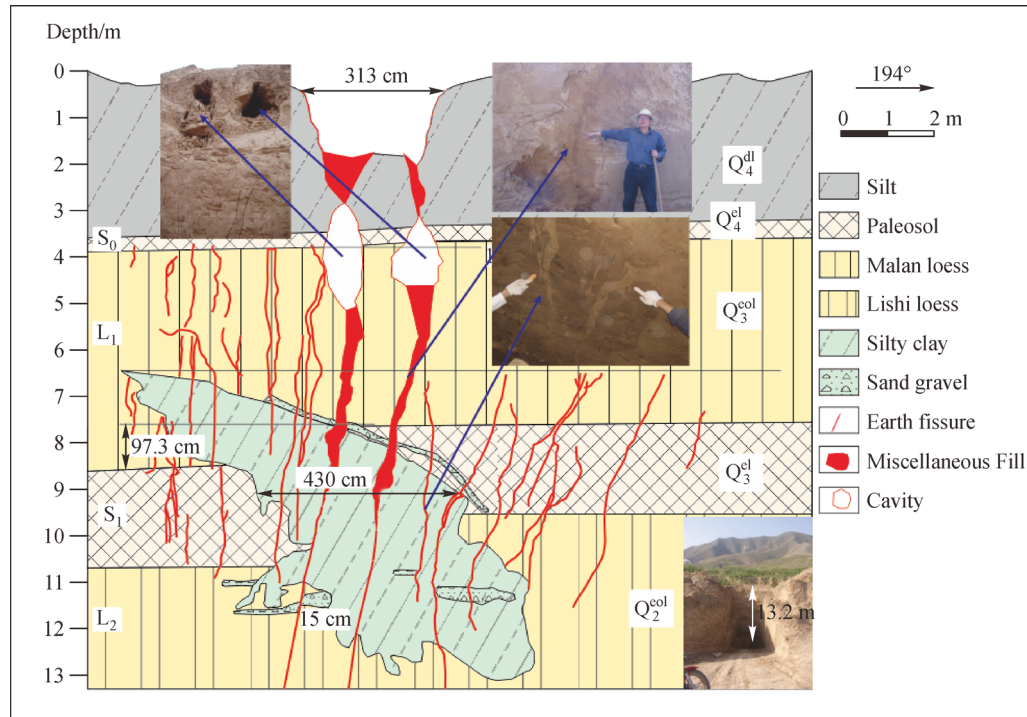
The trench also revealed Quaternary Holocene diluvium and Pleistocene aeolian sediments, eluvium, and diluvium (Fig. 5). The strata, from the top downward, consist of silt, palaeosol (S_0), Malan loess (L_1), silty clay, sandy gravel, palaeosol (S_1), and Lishi loess (L_2). As shown in the profile of the trench (Fig. 5), the S_1 palaeosol was dislocated, with silty clay and sandy gravel filling in the offset. The vertical offset of the S_1 palaeosol layer was 97.3 cm, and the horizontal displacement was approximately 430 cm. Thus, we speculate that this area experienced taphrogenic activity between 0.01 MaBP (the formation age of the bottom strata S_0) and 0.029 MaBP (the formation age of the top strata S_1). The taphrogenic activity resulted in many ancient earth fissures in the S_1 palaeosol and L_2 Lishi loess layers. Moreover, the trenching showed that two main earth fissures dislocated the strata, with the stratigraphic throws

Fig. 5 Trenching profile of Liangjia Village earth fissure.

varying and gradually increasing with depth. For example, the vertical offset was 10 cm in S_0 and 15 cm in the sandy gravel. We expect that larger stratigraphic throws will be found in deeper strata.

From the larger vertical dislocation of 97.3 cm in S_1 , we deduce that the taphrogenic activity corresponds to a larger-scale earthquake in the Late Pleistocene (Q_3), whereas the small vertical dislocations of 10 cm in S_0 and 15 cm in the sandy gravel layer suggest a relatively small-scale earthquake in the Holocene (Q_4). Thus, modern earth fissures can be traced back to the Late Pleistocene or even earlier.

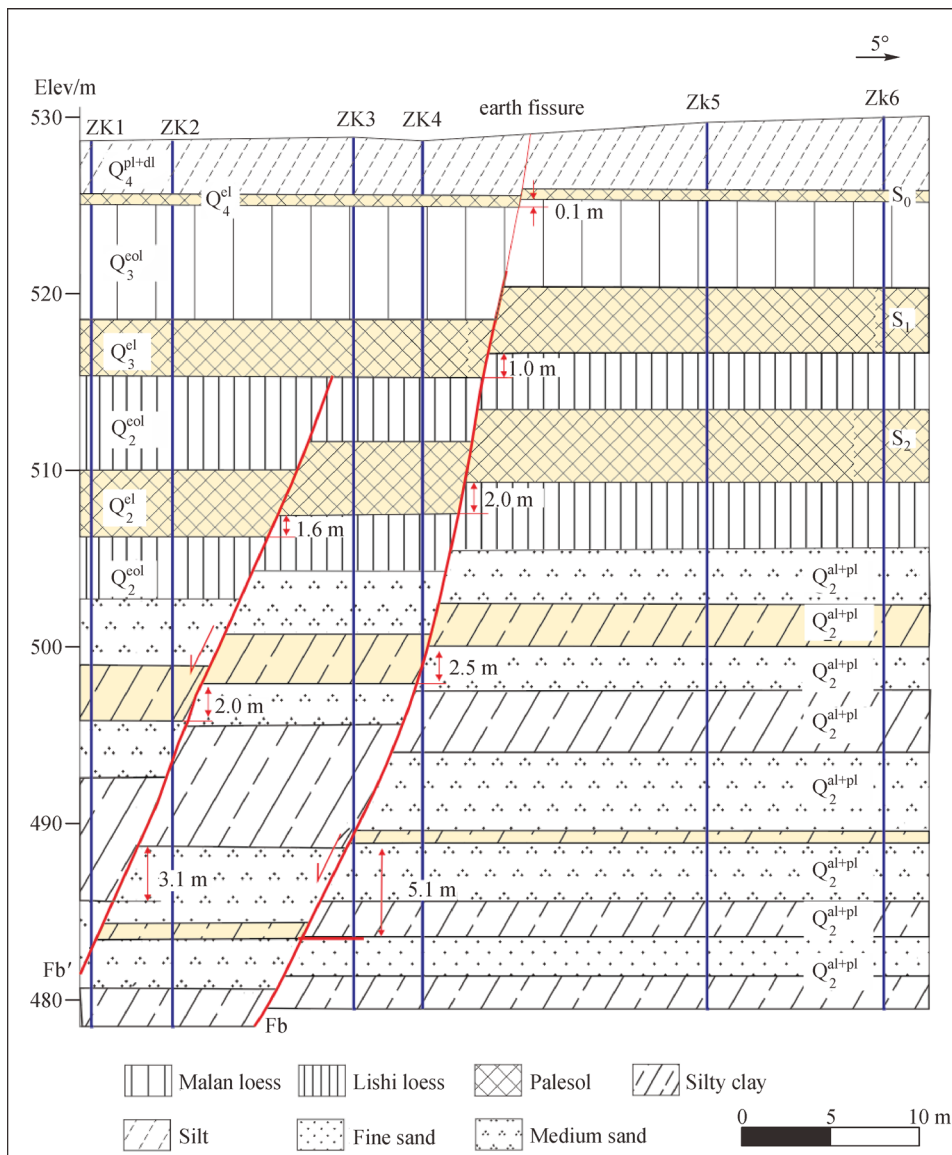
The characteristic cross-section of the Liangjia Village earth fissure for depths of 0 to 50 m was revealed by drilling. The geological drill line consisted of six drill holes laid out in northern Yujia Village (Fig. 3). The geological cross-section revealed 15 layers, and all the layers were dislocated by the earth fissure (f1) (Fig. 6). The stratigraphic dislocation started from the first palaeosol (S_0) layer at a depth of 4 m and a vertical offset of 0.1 m, which is consistent with the results revealed by trenching. As the earth fissure extended deeper, its vertical offset periodically increased, with an offset of 1 m in the second palaeosol (S_1) layer at a depth of 12 m, an offset of 2 m in the third palaeosol (S_2) layer at a depth of 19 m, an offset of 2.5 m in the silty clay at a depth of 29 m, and an offset of 5.1 m in the silty clay at a depth of 41 m. Beyond this

depth, the geological profile revealed that another buried fault (Fb') existed in the southern 13 m of the earth fissure (f1); the stratigraphic throw started from the third palaeosol (S_2) layer at a depth of 19 m and gradually increased with depth. These results indicate that the earth fissure exhibited the syn-sedimentary characteristics of an active fault.

Fig. 6 Geological cross-section of earth fissure in Liangjia Village. Fb&Fb', buried faults.

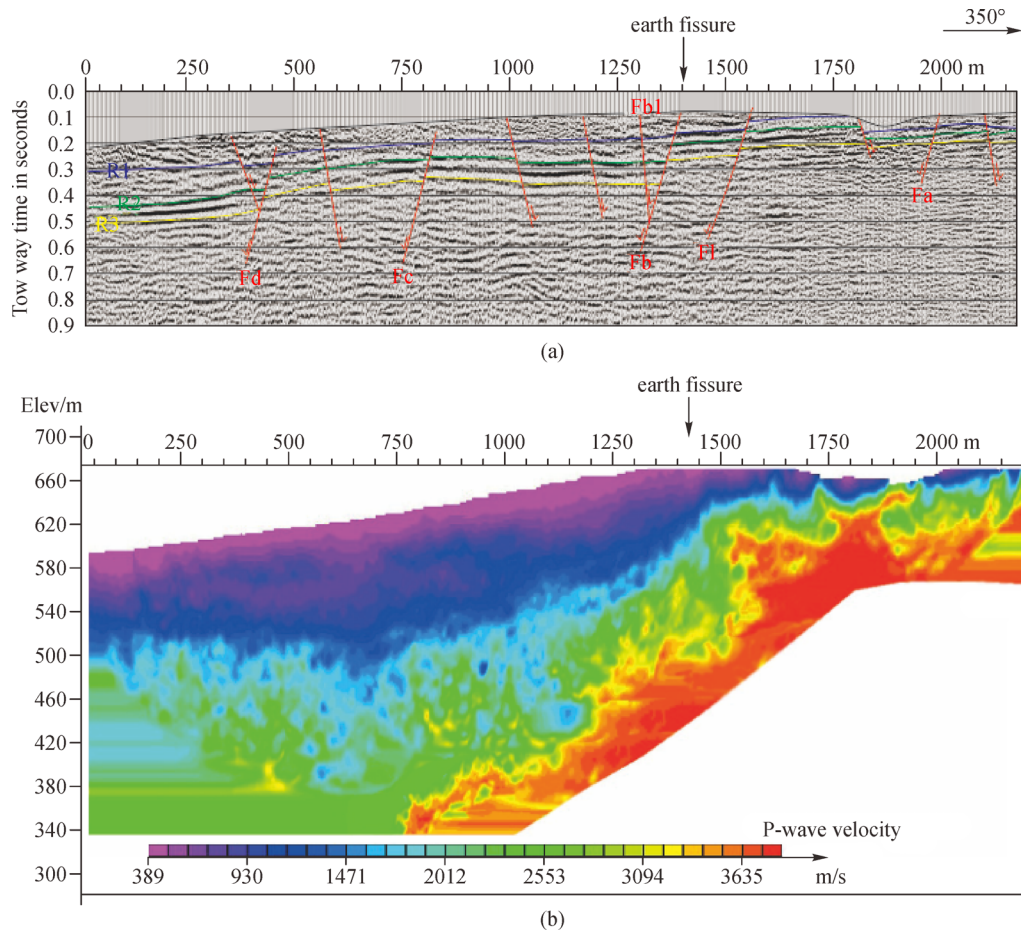
faults, and geophysical survey GS2 showed 15 buried active faults. The main fault inclined southward, whereas the secondary fault inclined northward, developed on the upper wall, and formed a Y-shape with the main fault. For identification, the main faults were named as Fa, Fb, Fc, Fd, and Fe. The Liangjia Village earth fissure is an outcrop of Fb that extends toward the earth's surface. Thus, the surface appearance of the earth fissure is parallel to the KGF (F1). The seismic reflection and velocity contour section show that the earth fissure is an outcrop of a buried fault (Fb) that extends toward the surface, where the vertical offset of the main earth fissure gradually increases with depth. These results are similar to those of a syn-sedimentary fault, and are consistent with the trenching and drilling results, further demonstrating that the ground fissure grew along the underlying fault.

Fig. 7 Results of geophysical survey GS1 across Liangjia Village earth fissure. (a) Seismic reflection profile, (b) p-wave velocity distribution for the uppermost 300 m of the reflection profile; F1: Kouzhen–Guanshan fault; Fa–Fd: buried faults; R1–R3: CT velocity stratification interfaces.

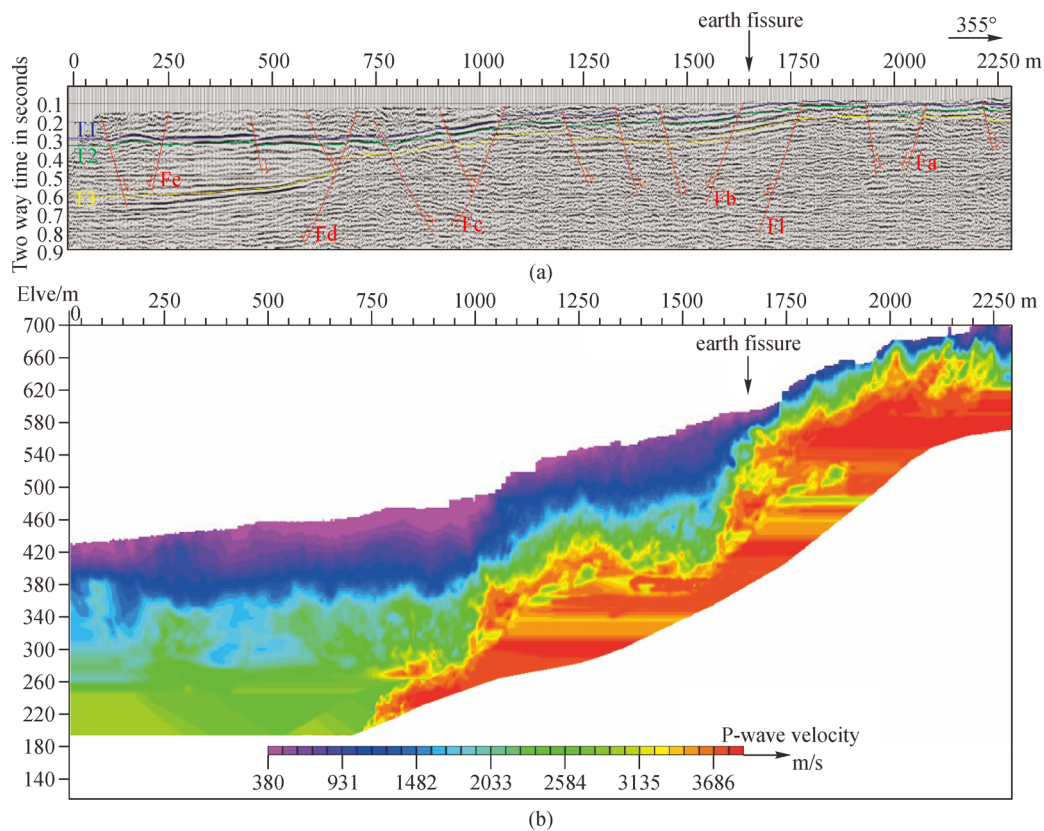
Fig. 8 Results of geophysical survey GS2 across Liangjia Village earth fissure. (a) Seismic reflection profile, (b) p-wave velocity distribution for the uppermost 300 m of the reflection profile; F1: Kouzhen–Guanshan fault; Fa–Fe: buried faults; T1–T3: CT velocity stratification interfaces.

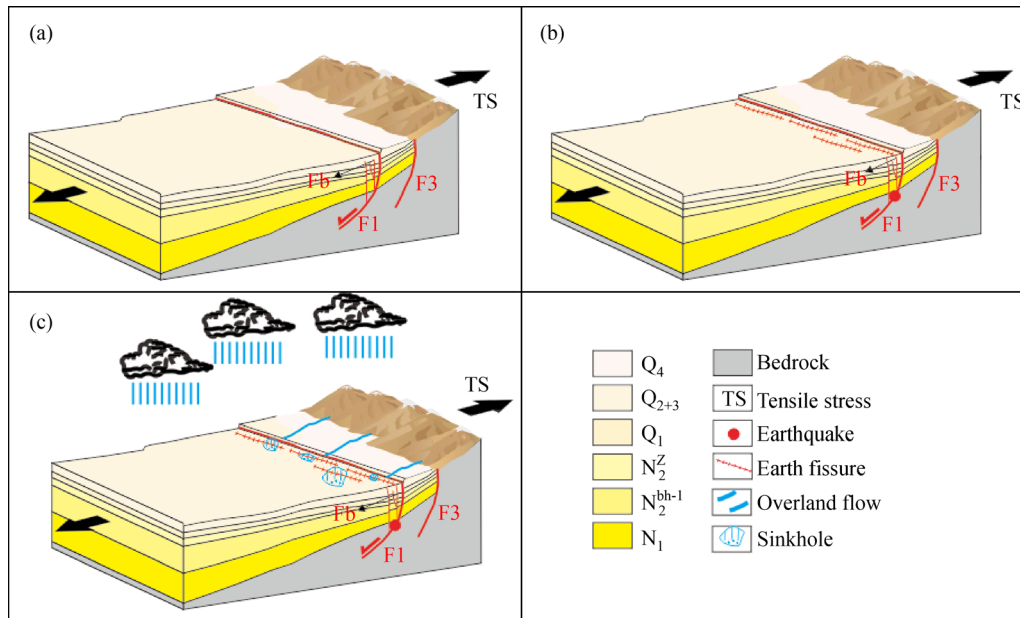
(L_2). It is well understood that loess is widely distributed on the hanging wall of the KGF. Loess has many special characteristics, such as fine particle size, macropores, and a weak tensile strength prone to collapse (Li et al., 2000; Sun et al., 2009). Field investigations found that many sinkholes and gullies have developed along the Liangjia Village earth fissure. Furthermore, overland flows are able to stand for extended periods on the hanging wall of the KGF after anomalous heavy rainfalls, and the preexisting earth fissure provides a preferred pathway for infiltration. The trenching results showed that some cavities have developed in the Liangjia Village earth fissure (Fig. 5). Analysis of these results suggests that the scouring of surface water and erosion caused by infiltration have caused earth fissures in the area to expand into gullies or sinkholes (Fig. 10(c)).

Fig. 10 Processes of Liangjia Village earth fissure (revised from Peng et al., 2016b). F1: Kouzhen–Guanshan fault; F3: Qishan–Qianxian fault; Fb: buried fault.
