Quantitative assessment of the influence of terrace and check dam construction on watershed topography

Keywords check dam, digital elevation model, Loess Plateau, terrace, topography

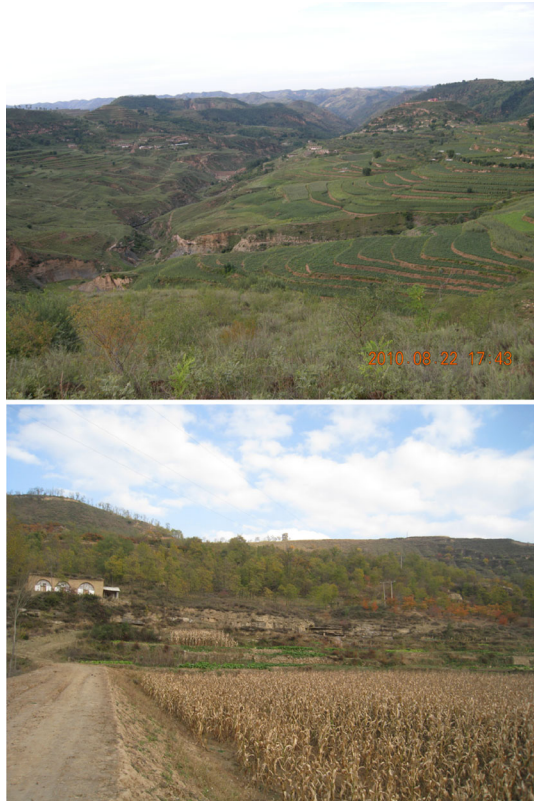
Fig. 2 Terrace (up) and dam land (down) landscapes in the Zhifanggou watershed.

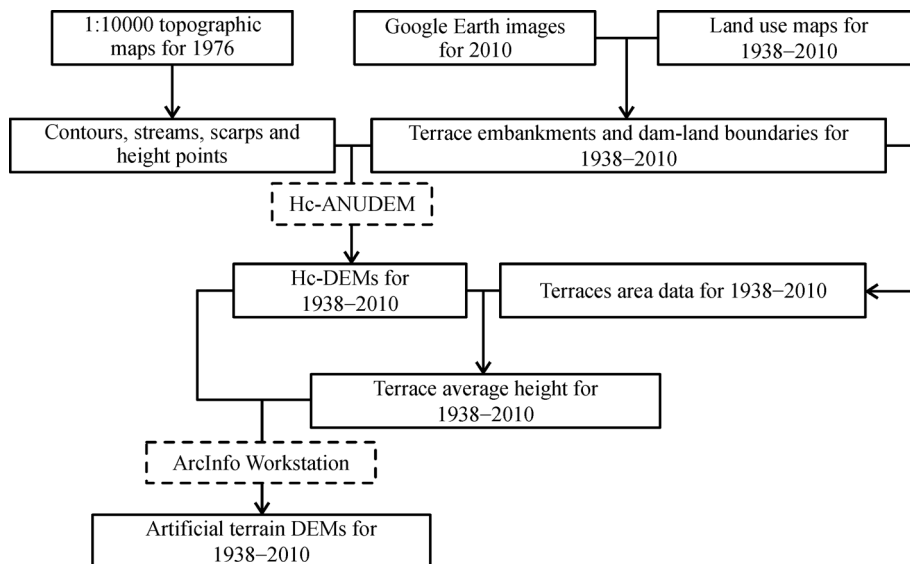
Fig. 4 The process of the artificial terrain DEM construction.

The process of artificial terrain DEM construction went as follows (Fig. 4): 1) Using the topographic data including contours, height points, streams, scarps, terrace embank-

ments, and dam land boundaries, the hydrologically correct DEMs (Hc-DEMs) for 1938–2010 were interpolated by running ANUDEM v5.1. By referring to the previous studies (Yang et al., 2006; Zhang et al., 2006; Shi et al., 2007), the second roughness coefficient, the elevation tolerance, and the number of iterations were set to 0.5, 5 m, and 20, respectively. Due to the presence of numerous narrow terraces within the study site, the grid size was set to 1 m. 2) The mean elevation for each terrace was calculated from Hc-DEMs using zonal statistics tool in ArcGIS v10.0. This tool computes the value for each zone defined by a zone data set (e.g., the terrace distribution area) using values from another raster data set (e.g., Hc-DEMs). 3) Mask operation was performed in the ArcInfo Workstation (ESRI Inc.), and the mean elevation for each terrace was embedded into the Hc-DEMs.

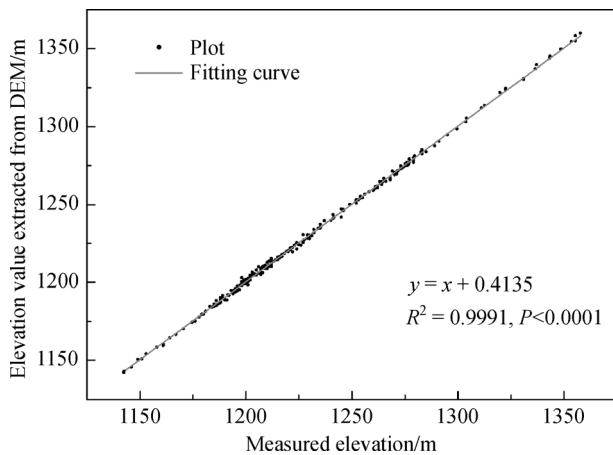
Fig. 6 Relationship between the artificial terrain DEM-extracted and the measured elevations.

The *MRE*, *MAE*, and *RMSE* can reflect the overall quality of a DEM. These index values between the artificial terrain DEM-extracted and the measured elevations were 0.008, 1.0343, and 1.1916, respectively. The correlation coefficient was 0.9996, indicating that the artificial terrain DEM-extracted and measured elevations were linearly and tightly correlated (Fig. 6). According to the 1:10 000 DEM precision standard of China (ISMS, SBSM, 2010), the artificial terrain DEM we established met the secondary standard.

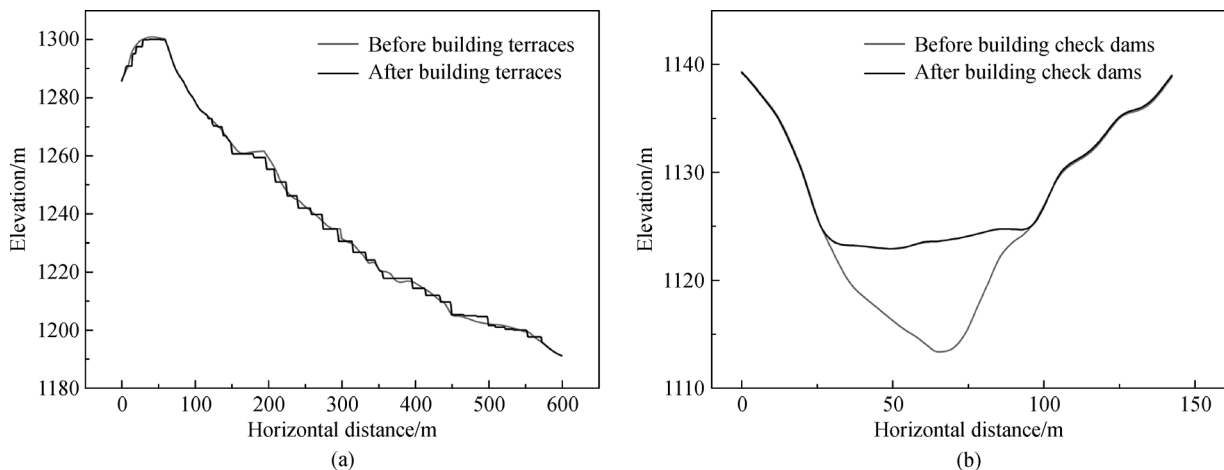
Fig. 7 Elevation cross sections before and after constructing (a) the terraces and (b) check dams.

The cross sections on the DEM, before and after constructing terraces and check dams (Fig. 5), were respectively extracted (Fig. 7). The results showed that the surface morphology changed substantially under the effect of artificial transformation. Before building terraces, the slope height profile was relatively smooth, reflecting the rolling surface morphology. However, after building

the terraces, the slope height profile showed a ladder-like distribution, indicating that the local land surface became flat due to the digging-filling of the original surface. After constructing the check dams, the surface was uplifted due to subsequent sediment accumulation, generating a significant change in the channel in that it gradually evolved in shape from a “V” into a “U”.

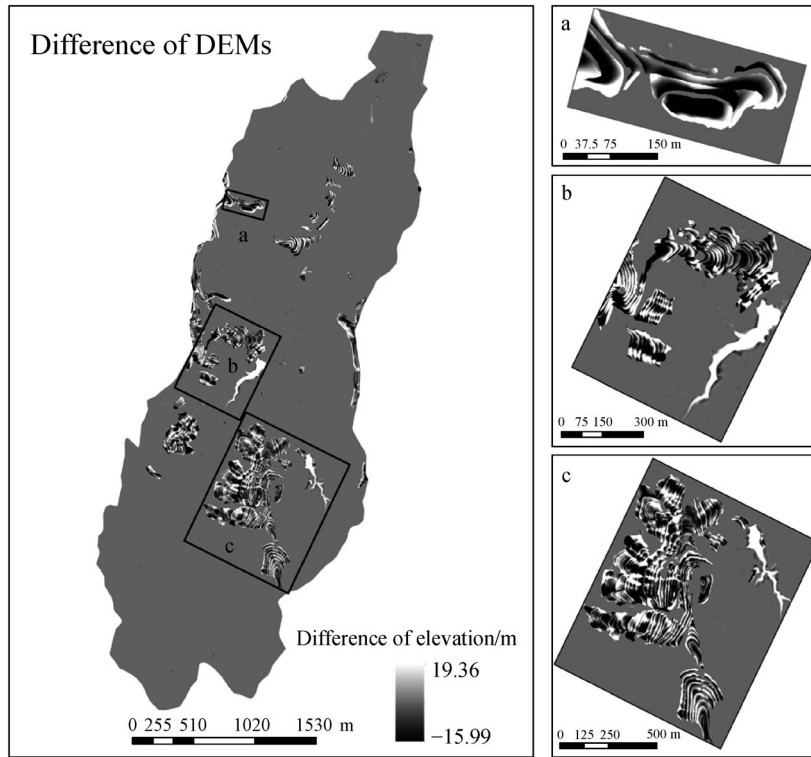
Fig. 8 Difference between the original DEM and artificial terrain DEM for 2010.

For the quantitative analysis of elevation change, we compared the original DEM and artificial terrain DEM for 2010 (Fig. 8). We found that the elevation change mainly occurred in the middle-to-down streams of the Zhifanggou watershed and the elevation value varied from -15.99 to 19.36 m. Surface elevation changes were due to the construction of terraces and check dams. We analyzed the respective influences of terraces and check dams on the surface elevation in the following sections.

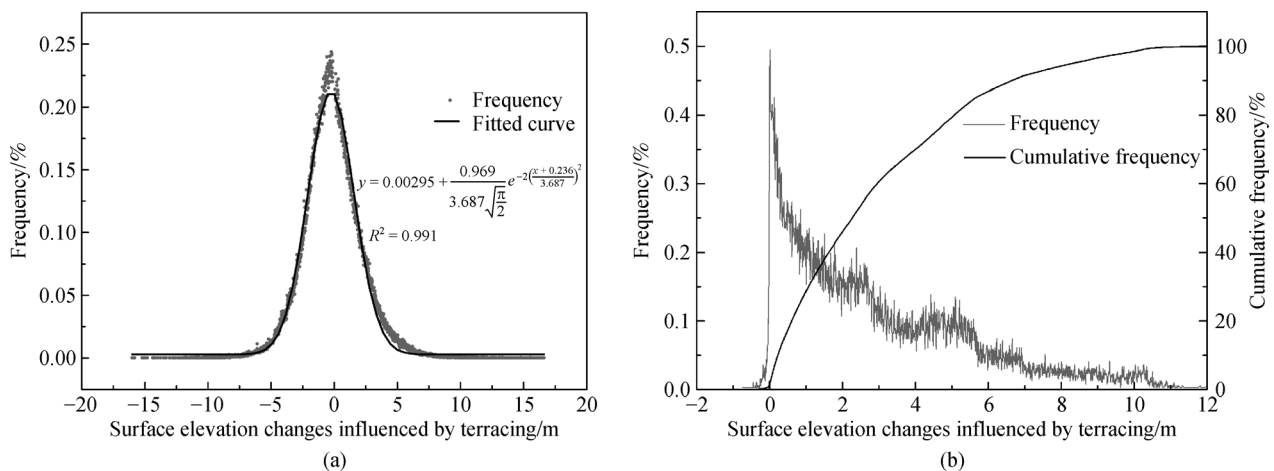
Fig. 9 Frequency of elevation changes influenced by (a) terracing and (b) sediment deposition from dams in the Zhifanggou watershed.

Statistical analysis revealed that the frequency of elevation changes influenced by terracing in the terraced area followed a normal distribution (Fig. 9(a)). To further explore and explain these surface changes, we calculated the intervals of elevation change frequency according to the normal distribution curve, i.e., $(\mu - \sigma, \mu + \sigma)$, $(\mu - 1.96\sigma, \mu + 1.96\sigma)$, and $(\mu - 2.58\sigma, \mu + 2.58\sigma)$. The percentage of elevation changes occurring between -2.08 and 1.61 m

was 63.12%; between -3.85 and 3.38 m it was 89.38%, while that between -4.99 and 4.52 m accounted for 95.40% of all changes.

Statistical results of the surface elevation changes influenced by check dam deposition in the watershed are shown in Fig. 9(b). Just 1.18% of the elevation in the check dam deposition area had decreased, which may be related

to slope collapse during the deposition process and tillage. By contrast, under the effect of deposition, 98.82% of the elevation in the dam land deposition area increased. Specifically, the percentage of deposition height within 3 m was greatest (59.35%), followed by those in 3–5 m (18.78%) and 5–10 m (19.18%) ranges; the percentage of deposition height > 10 m accounted for just 1.51% of the total dam land area.

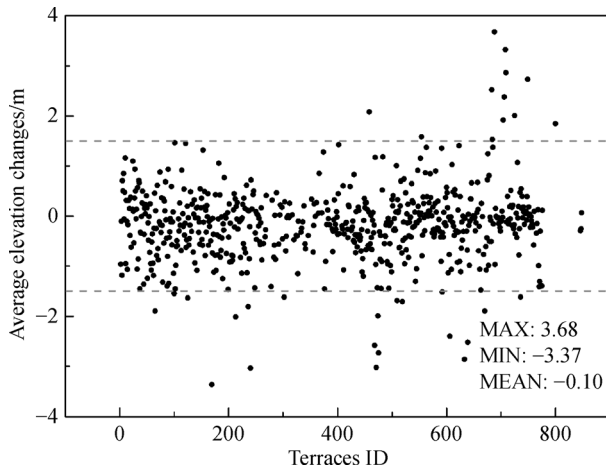
Fig. 11 Average elevation change of each terrace in the Zhifanggou watershed.

and 1.5 m, which accounted for more than 95% of all the total changes (Fig. 11).

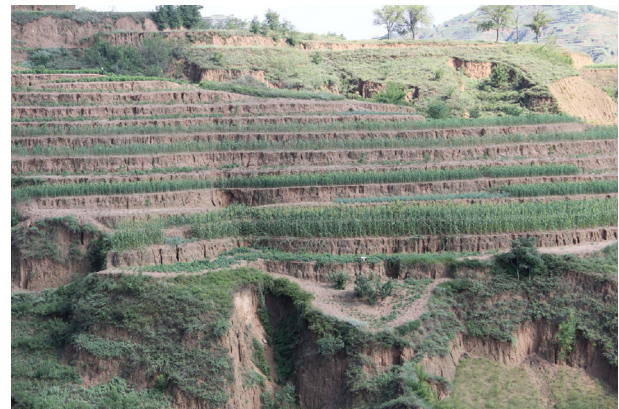
Fig. 15 Part of the terraces damaged in the Suide 7.26 heavy rainfall event in the Jiuyuanguo watershed (Photo taken by Qinke Yang on July 29, 2017).

Compared with the original slope, though the average slope decreased after building the terraces, the slope of terrace embankments increased sharply in the Zhifanggou watershed. The area near the terrace embankments is currently under the influence of a steep hydraulic gradient, which may lead to ongoing gully erosion and piping (Lesschen et al., 2009). Under extreme rainfall conditions especially, the terrace embankments are prone to gravity erosion and terrace damage (Fig. 15). Nonetheless, once

the terrace embankments are destroyed, the large amount of sediment stored behind the terraces forms a potential source of sediment that may be easily released following terrace failure (Lesschen et al., 2008). Therefore, the existing terrace embankments should be strengthened; for example, by restoring collapsed terrace embankments and piping, and by planting indigenous grass species on terrace embankments for retaining surface runoff.
