The impact of Typhoon Lekima (2019) on East China: a postevent survey in Wenzhou City and Taizhou City

Abstract Typhoon Lekima (2019) struck Zhejiang Province on 10 August 2019 as a supertyphoon, which severely impacted Zhejiang Province. The typhoon killed 45 people and left three others missing, and the total economic loss reached 40.71 billion yuan. This paper reports a postdisaster survey that focuses on the storm precipitation, flooding, landslides, and weather services associated with Typhoon Lekima (2019) along the southeastern coastline of Zhejiang Province. The survey was conducted by a joint survey team from the Shanghai Typhoon Institute and local meteorological bureaus from 26 to 28 August, 2019, approximately two weeks after the disaster. Based on this survey and subsequent analyses of the results, we hope to develop countermeasures to prevent future tragedies.

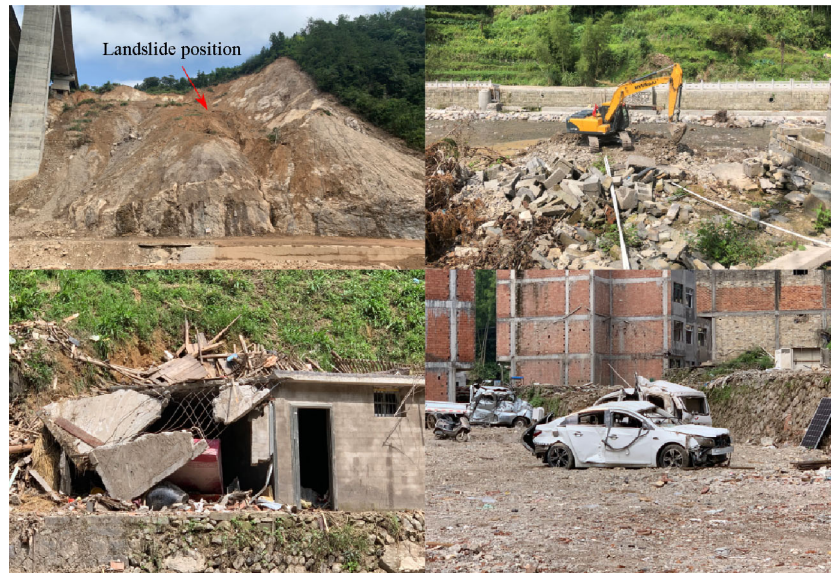
Fig. 2 Photographs of the disaster investigation field in Shanzao village, Yongjia county (Cong ZHOU, 2019-08-28 took photos). The red arrows indicate the position of the landslide.

and Droughts, 3723000 residents were affected, three people died, 4107 houses collapsed, 1110 km² of plants were affected, and 2130 km² of plants faced destruction in Taizhou city. The direct economic loss was approximately 25 billion yuan. Although Typhoon Lekima (2019) made landfall in Wenling, Taizhou city, it caused more severe damage to life in Wenzhou city, located south of Taizhou city. In Wenzhou city, 1702700 residents suffered, 36 people died, two people were missing, 181 houses collapsed, 168.03 km² of plants were affected, and 4.73 km² of plants faced total failure. The total direct economic loss reached 30 billion yuan. The different disaster situations in the two cities are related to the regional topography, which will be discussed in detail below. Field surveys and interviews with residents indicated that most of those killed died in Yongjia county, Wenzhou city. The landslides blocked a stream, water levels rose 10 m in ten minutes, and many residents could not evacuate in time to avoid injury or death. Some photos were taken at the disaster sites in Shanzao village, Yongjia county (Fig. 2).

Typhoon Lekima (2019) making landfall, the rainfall in Shanzao village exceeded 160 mm in 3 h, which caused a landslide at the entrance to the village. Figure 2 shows the landslide position and the surrounding environment. The landslide blocked a stream, which caused water levels to

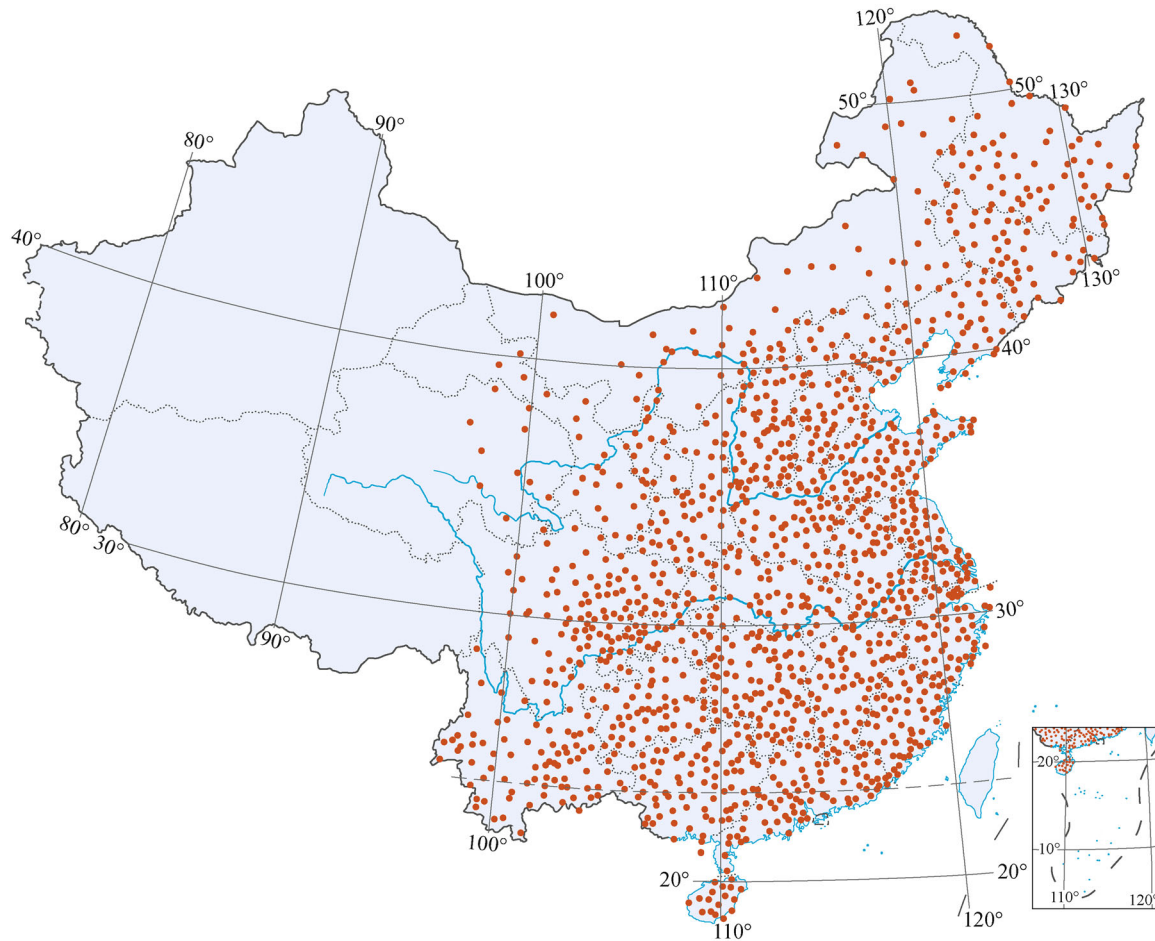
Fig. 5 Distribution of the 1401 stations chosen to analyze the precipitation and wind.

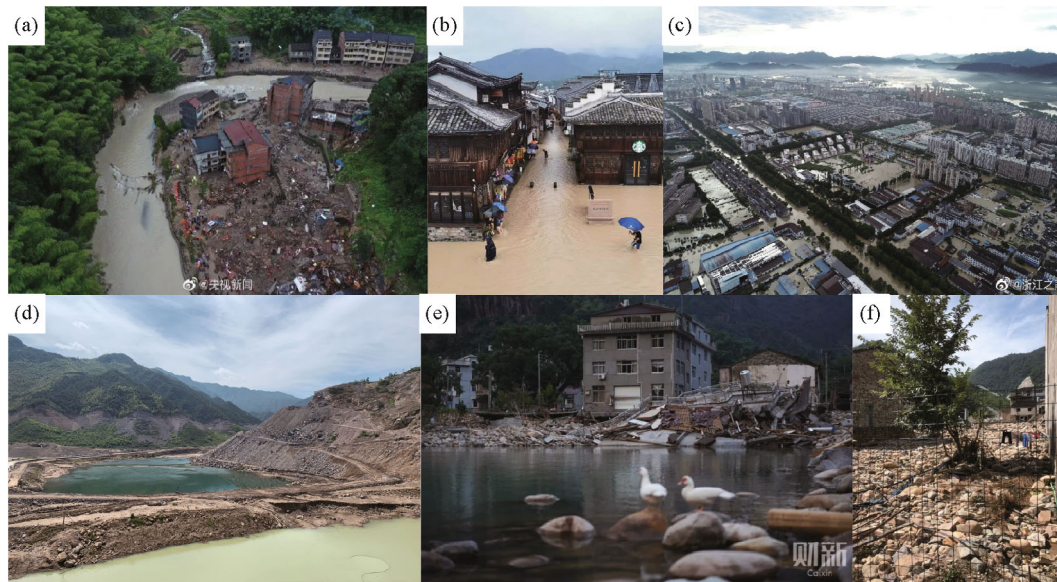
Fig. 6 Pictures of (a) an aerial photo of Shanzao village, Yongjia county (Source: Sina Weibo @CCTV News), (b) Linhai ancient city (Source: Website of The Paper News), (c) an aerial photo of Linhai city on 11 August (Source: Sina Weibo @The Voice of Zhejiang), (d) an unfinished reservoir, (e) collapsed buildings (Source: Website of Caixin News), and (f) exposed tree roots and channel.

took place in Taizhou city and Wenzhou city. Here, we focus on 3 cases: Case 1 – Case 3. Figure 6 shows pictures of (a) an aerial photo of Shanzao village, Yongjia county (Source: Sina Weibo @CCTV News), (b) Linhai ancient city (Source: Website of The Paper News), (c) an aerial photo of Linhai city on 11 August (Source: Sina Weibo @The Voice of Zhejiang), (d) an unfinished reservoir, (e) collapsed buildings (Source: Website of Caixin News), and (f) exposed tree root and channel. As most survey sites were in the drone no-fly zone, we selected some photos from the Internet. Figure 7 and Figure 8 show satellite images of Linhai city before and after the flood.

worst-hit area was located at the bend of the stream, an area near the entrance to the village with low topography (Fig. 6(a)).

Case 3: A flash flood caused by torrential rains affected 41 buildings in Fangxi village, 20 km from Linhai (survey site B in Fig. 1). Fortunately, the villagers were evacuated early, and no people were in the homes when they collapsed into the stream. Fangxi village is a small village with approximately 500 people located in the lower reaches of the Fangxi River, a tributary of the Yonganxi River. An unfinished reservoir was located upstream of the river (Fig. 6(d)). On the evening of 9 August, a copious amount of rain fell in the reservoir in a short period. It was then discharged directly through two temporary drainage culverts, causing damage to the lower village, which was less than 500 m downstream. In the survey, we saw that houses on the upper side of the village, on the side next to the river, were almost thoroughly washed out and covered in rubble. A three-story building not far from the village council was tilted, with its foundation and steel bars visible. Large boulders covered much of the village, as did the rubble from many collapsed houses on the sides of the river (Figs. 6(e) and 6(f)). Based on the residents' interviews, the houses were destroyed by the rocks transported by the flood (Fig. 6(f)).

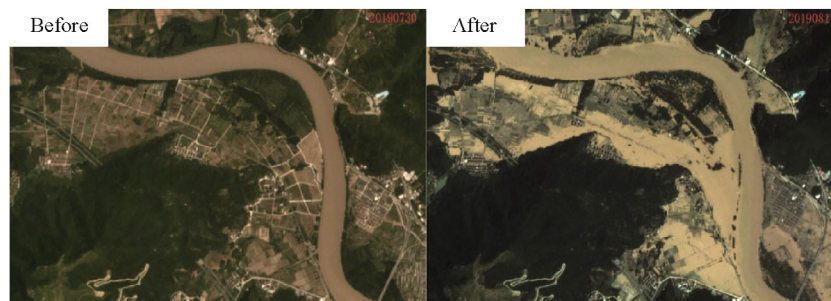
Fig. 7 Satellite images of the Lin River before and after the flood (Source: Sike website).

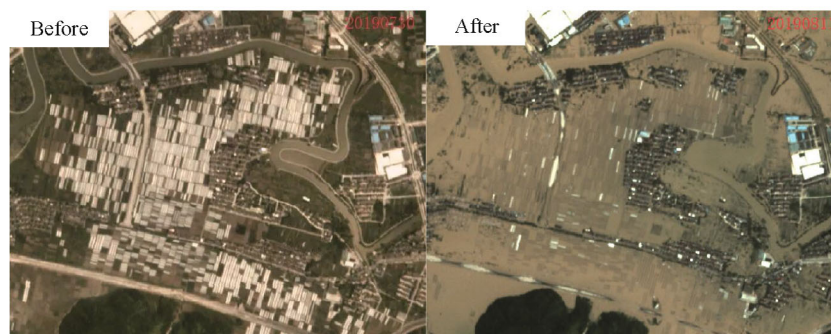
Fig. 8 Satellite images of Jianchuan village, Linhai city, before and after the flood (Source: Sike website).
