Geotechnical and geophysical studies for the cause of landslide in Lesalso, Laelay Maichew Wereda, northern Ethiopia

Abadi Gebrehiwot^{a,*}, Gebremedhin Berhane^b, Yewhalashet Fissha^{a,c}, Yemane Kide^a,
Welegerima Teklay^a, Belaynesh Mekonen^d, Enming Li^{e,**}

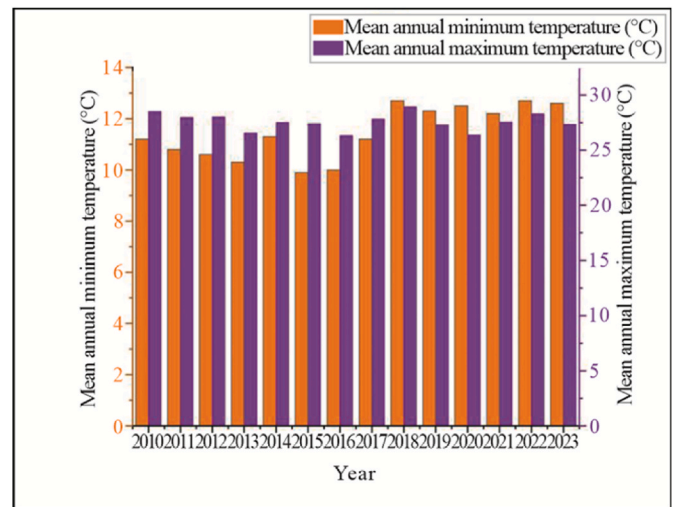
Fig. 2. Shows column plots of the maximum and minimum temperature distribution within the year of 2010–2023 [12].

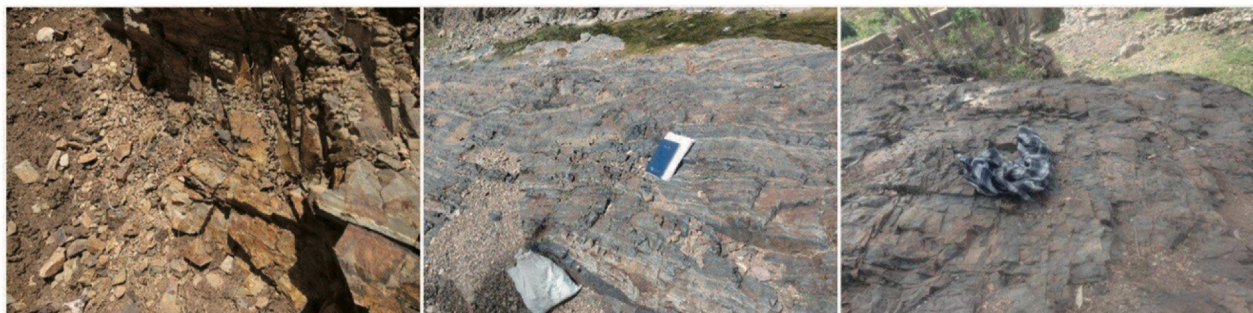
Fig. 8. Metachert rock units.

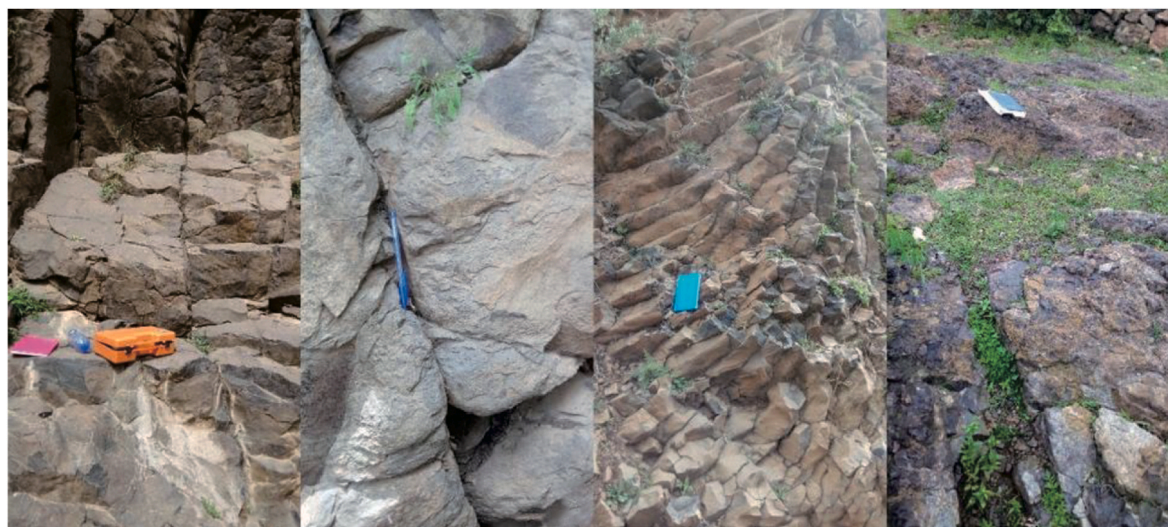
(a) Joint sets (b) Joint with irregular fractures (c) Columnar joint (d) Joint with high aperture in laterite sandstone

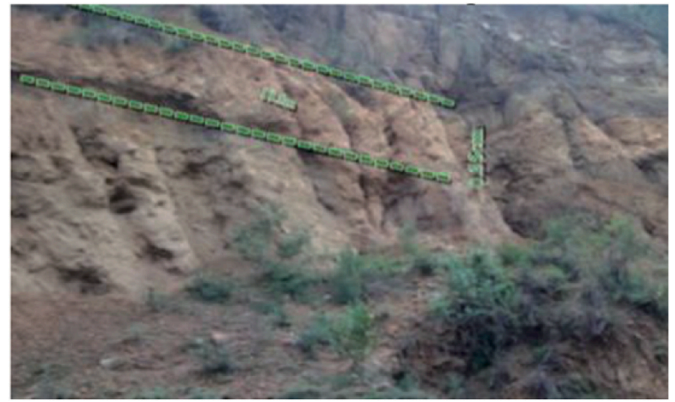
Fig. 14. Sill intrusion in aphanitic basalt rock unit.

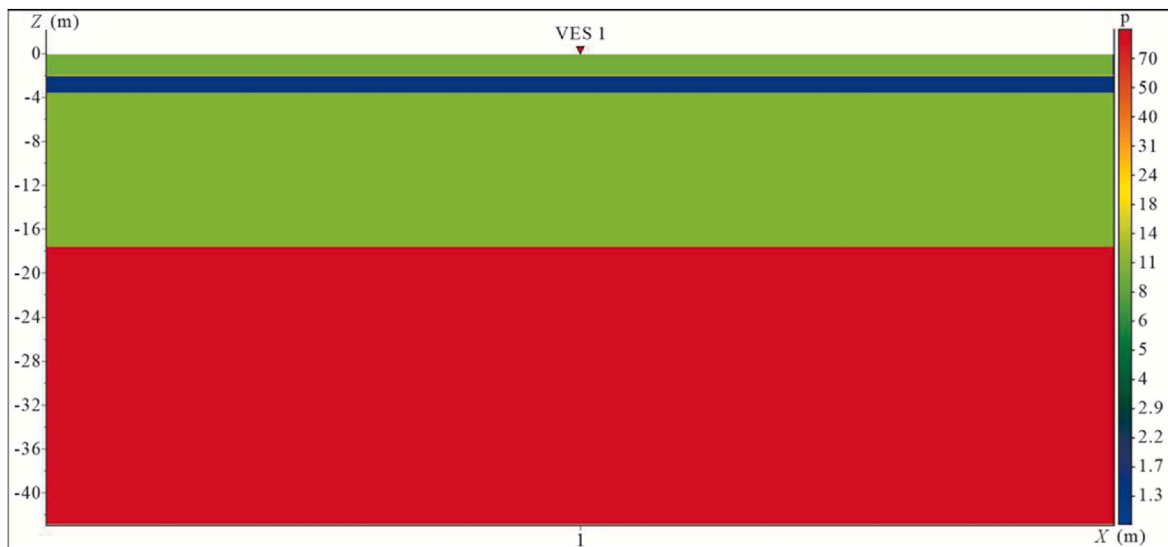
Fig. 22. Apparent resistivity pseudo-depth section map along profile line 1.

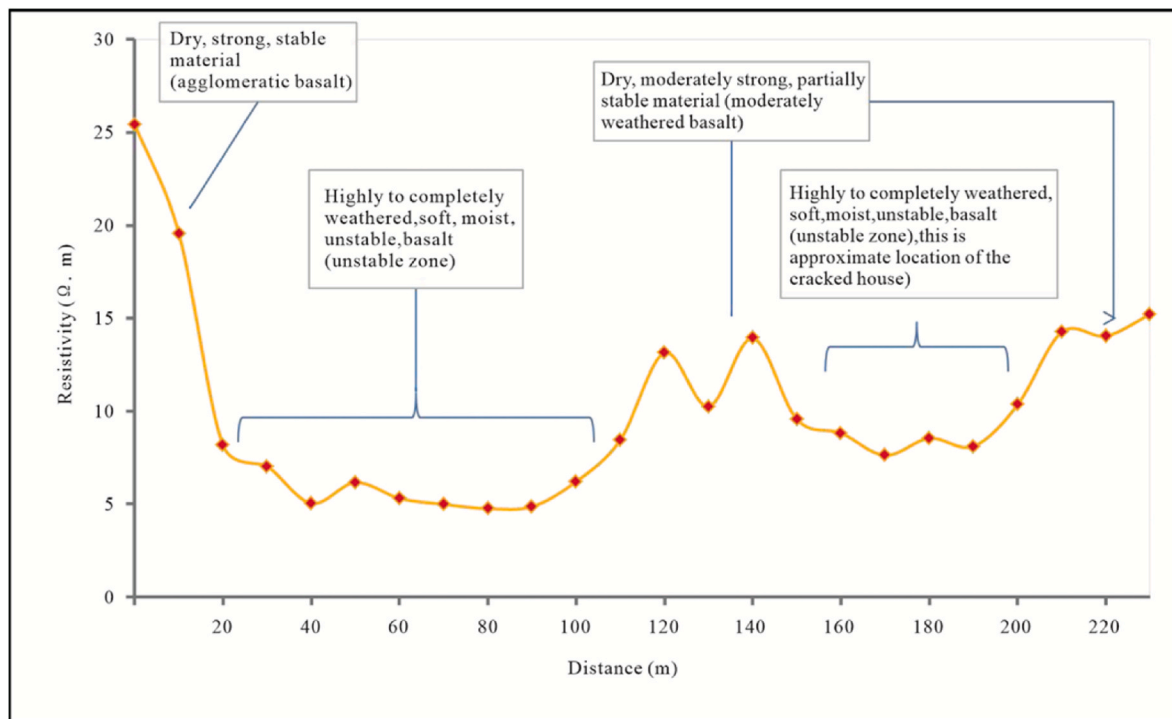
Fig. 23. Profile line one preliminary interpretation (GPS) of last reading (X: 478621 mE, Y: 1564187 mN, Z: 2124 m. a. s. l).
