Rapid report of seismic damage and consequence analysis in the 2025 M 6.8 Dingri earthquake

Qingxue Shang^{a,b,c,*}, Zhongyi Zhou^{a,b,**}

Following the earthquake, the research group arrived at Dingri County immediately for earthquake damage assessment. This report focuses on seismic damage of local houses and buildings, and the casualty causes of this earthquake. The investigated area of this report is shown in Fig. 1 and a detailed discussion of the post-earthquake investigation results will be given in the following Sections.

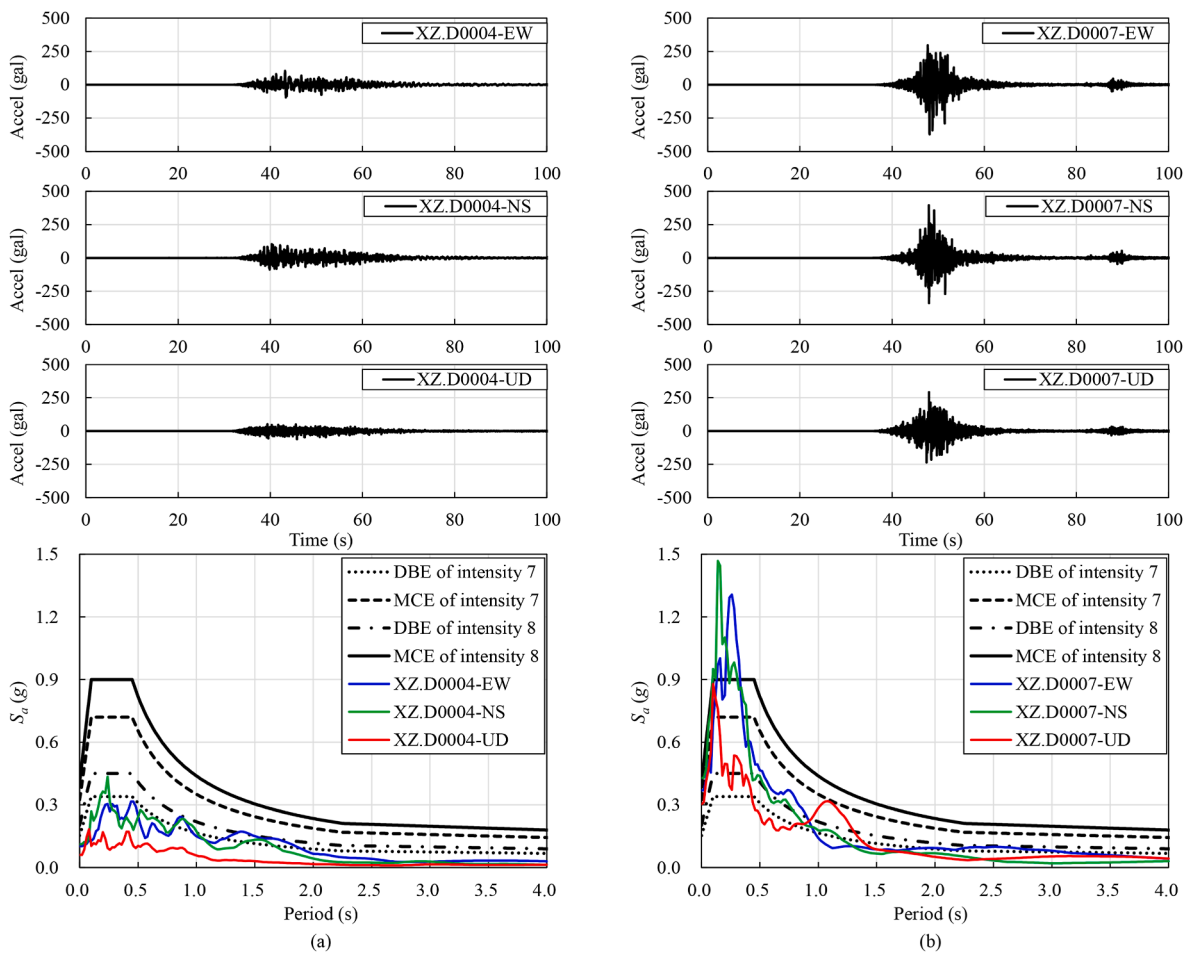
Fig. 2. Acceleration time histories and corresponding acceleration response spectra (5% damping ratio, Class II Group 3 site for design spectra), (a) Station XZ.D0004, and (b) Station XZ.D0007.

The Station XZ.D0007 (29.09° N, 87.63° E) located near the epicenter recorded the three-component strong ground motion acceleration time histories, as shown in Fig. 2. Among all the available stations, Station XZ.D0007 was closest to the epicenter and recorded the largest PGA values. The peak values of the acceleration and velocity time histories, filtered by a bandwidth of 0.1 Hz–25 Hz, of the records are listed in Table 2. According to the requirements in GB 18306-2015 (2016), the DBE level PGA demand for Lazi Town of Lazi County is 0.20 g. It corresponds to Intensity 8 for seismic design of buildings as per the Code for Seismic Design of Buildings in China (GB 50011-2010 (2016)). The corresponding PGA demand at the maximum considered earthquake (MCE) level is 0.40 g, with an exceedance probability in 50 years of 2%–3%. The PGA recorded by Station XZ.D0007 in this earthquake is 0.37 g, 0.43 g and 0.30 g in east-west (EW), north-south (NS) and vertical (UD) direction, respectively, which are significantly higher than the local DBE level value. The pseudo-acceleration response spectra of the records are also compared with the respective local design spectra at the DBE and MCE levels in Fig. 2. It is worth noting that the corresponding parameters of 5% damping ratio, Class II and Group 3 site were used for generation of the design spectra. The corresponding

characteristic period value of this site classification is 0.45 s. The design spectra of both intensity 7 and 8 areas are included here. The EW and NS components recorded at Station XZ.D0007 are higher than the designed response spectra of MCE level of Intensity 8 in the period of 0.1 s–0.35 s, which covers most of the vibration periods of local houses and buildings. However, the spectra values were significantly lower than the design response spectra of MCE level of Intensity 8 when the period goes beyond 0.35 s. Station XZ.D0004 (28.37° N, 87.78° E) is another station, which recorded comparable PGA values, however, still much smaller than the recorded values at Station XZ.D0007. The acceleration response spectra of Station XZ.D0004 are comparable with the DBE level design spectra of intensity 7 for short-period range but lower than the DBE level design spectra of Intensity VII when the period goes beyond 0.35 s.

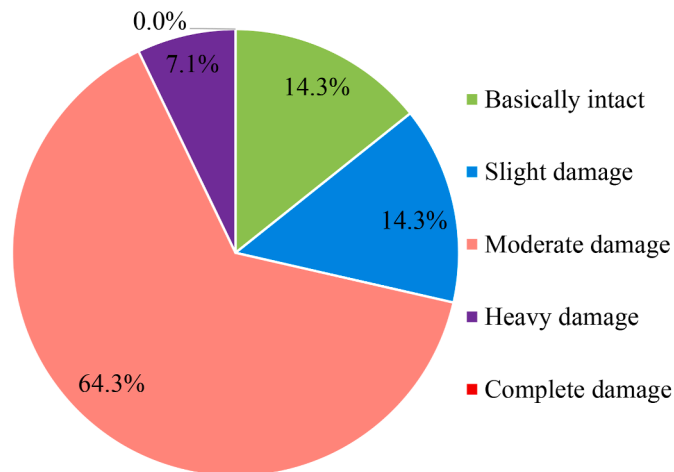
Fig. 16. Proportion of evaluated damage levels for investigated public buildings.

Based on the observed structural damage and non-structural damage of the investigated buildings, the post-earthquake seismic damage levels of these buildings were evaluated as per GB/T 24335-2009 (2009). A total of 14 public buildings were investigated, and the structural systems are mainly reinforced concrete frame structures and masonry structures. An illustration of seismic damage level classification standard for reinforced concrete frame structures after earthquakes is listed in Table 3. Based on the structural damage, most of these buildings are classified as

basically intact or slight damage. However, most are in moderate damage state if the non-structural damage and post-earthquake building functionality were considered. The proportion of evaluated damage levels was shown in Fig. 16. 64.3% of the investigated public buildings were in moderate damage level after this earthquake, and 7.1% were in heavy damage level. After the earthquakes, people in these buildings were all evacuated urgently and suffered partial loss of functionality. It should be noted that due to the limited human, material and time resources during the post-earthquake emergency period, the investigation didn't cover all the buildings in the earthquake-affected area, resulting in a relatively small sample size. However, for seismic damage of public buildings, the onsite investigation results are similar as discussed in Sections 4.1 and 4.2.

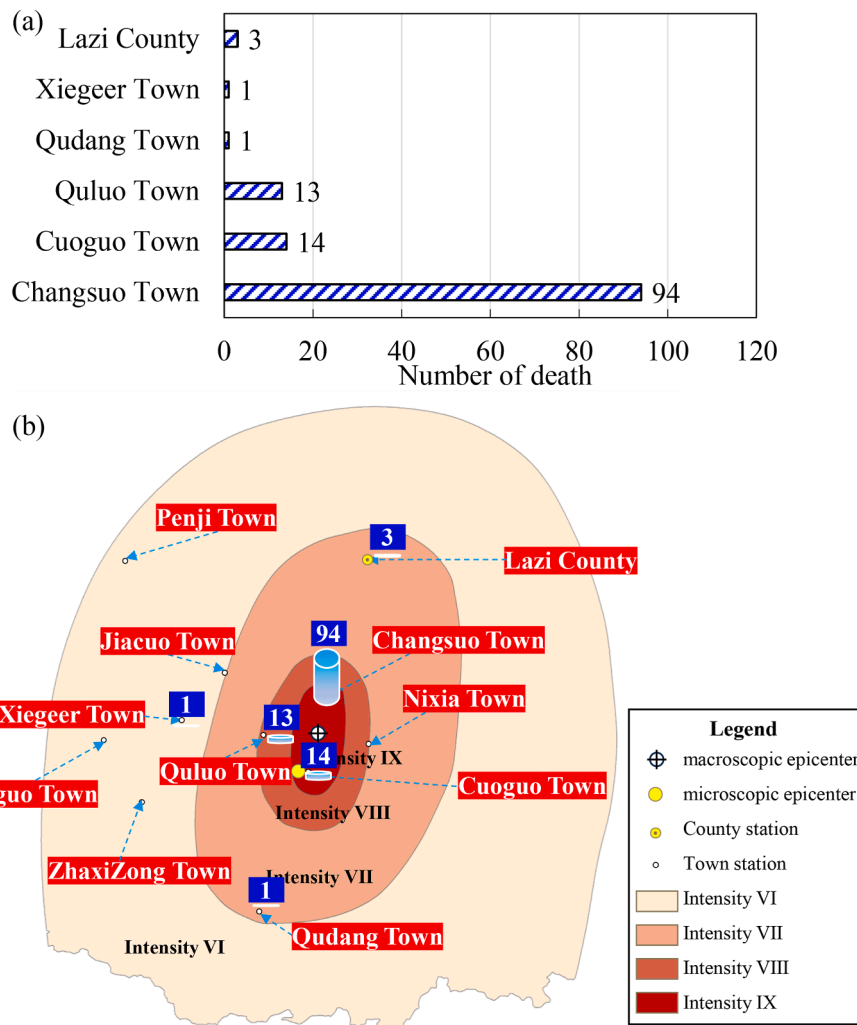
Fig. 17. Casualty distribution, (a) statistical data, and (b) spatial distribution.

A total of 126 people died during the earthquake, and the spatial distribution shows an obvious aggregation trend. 123 died people were distributed in several towns of Dingri County near the epicenter, including Changsuo Town, Cuoguo Town, Quluo Town, Qudang Town, and Xiegeer Town. And three died people distributed in Lazi County, as shown in Fig. 17. Changsuo Town is located in the intensity IX area of this earthquake and 94 people died, which accounts for 75.2% of the total death number. Apart from the seismic damage of rural self-built houses, another important reason for the large number of deaths in Changsuo Town is the strong fault activity in this area. From the surface fracture tracking investigation in Changsuo Town, it can be seen that there exists significant vertical dislocations, up to 3.0 m (Liang et al. (2025)). Fourteen people died in Cuoguo Town (IX degree zone), 13 people died in Quluo Town (VIII degree zone), one person died in Qudang Town (VII degree zone), and one person died in Xiegeer Town (VI degree zone), as presented in Fig. 17b.

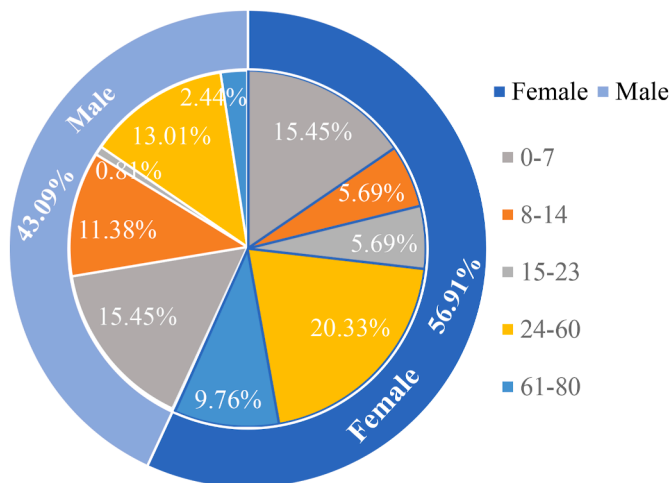
Fig. 18. Age and gender distribution of the death.

The age and gender of 123 people who died in this earthquake in Dingri County were summarized in Fig. 18. Most of the earthquake deaths were female, specifically 70 females, accounting for 56.9% of the

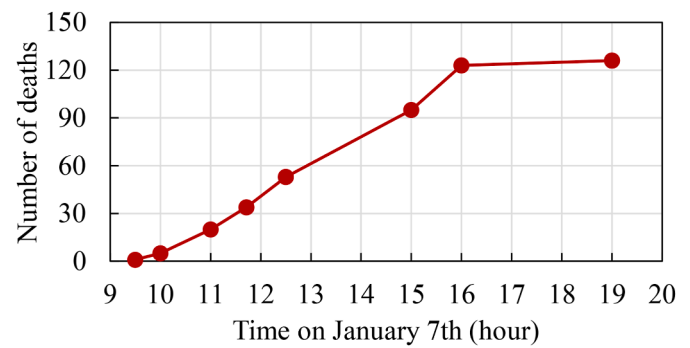
Fig. 19. Increase trend of casualty number with time.

The earthquake affected area located in the high altitude area of the plateau with an average altitude of more than 4 300 m. And the earthquake occurred in winter. The local temperature is significantly low as the local minimum temperature reached minus 18 °C. The low temperature has a great impact on the survival rate and health status of buried and trapped people. The injured people will have fast physical consumption and the body's tolerance will be reduced, e.g., the physiological functions will decline, the heartbeat and breathing will slow down, the blood pressure will decrease, and even will be in confusion and other symptoms of hypothermia. If the buried one cannot get timely rescue, they will be in coma or even death. In addition, due to the scattered distribution of villages, it was difficult to collect earthquake information, the rescue arrival time was not timely, and the death rate of

injured people trapped under low temperature conditions increased significantly. The increase of death number after the earthquake occurrence is presented in Fig. 19. It can be found that the number of death almost increased linearly with the time. The casualty number increased to 126 at 10 hr later after the earthquake occurrence. Therefore, the rescue time is usually quite short for post-earthquake emergency rescue at high altitude and low temperature areas, which reminds that the emergency response should be as quickly as possible for buried and trapped people rescue.
