RESEARCH ARTICLE

Le WANG, Yuelan DI, Ying LIU, Haidou WANG, Haoxing YOU, Tao LIU Effect of TGO on the tensile failure behavior of thermal barrier coatings

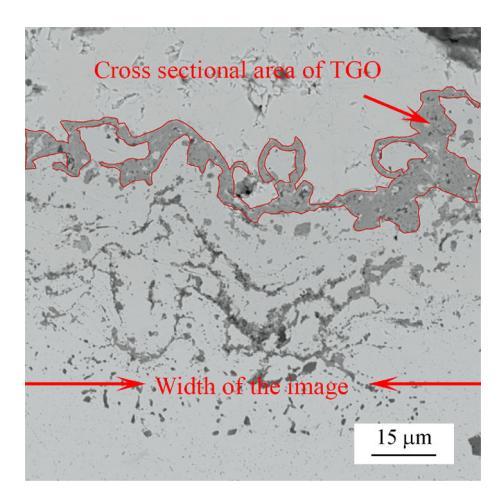
After high-temperature oxidation, TGO began to form at the interface between the ceramic and bonding layers. Figure 1 shows a schematic view of the thickness measurement region of TGO. The thickness of TGO was measured using the method of average thickness, namely,

Fig. 1 TGO thickness measurement area

The continuous TGO region was divided into five parts on the average, and the same multiple SEM pictures were obtained from each part. According to Eq. (1), the measured TGO thicknesses was the average value of the five results obtained by the measured TGO areas on the image divided by the width of the image.

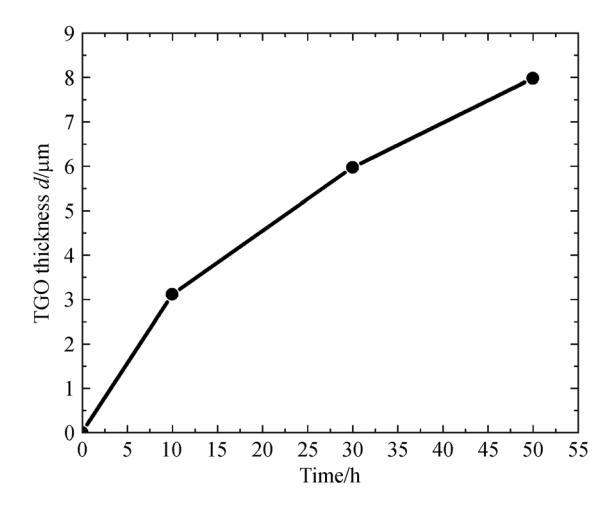
Figure 2 shows the line chart of the thickness variation of TGO. Overall, the growth rate of TGO gradually decreased as the oxidation time increased because TGO is a dense oxide film that reduces the contact between oxygen and metal elements; the rate of oxidation gradually slows down with the consumption of metal elements [22–24].

Fig. 2 Thickness variation of TGO

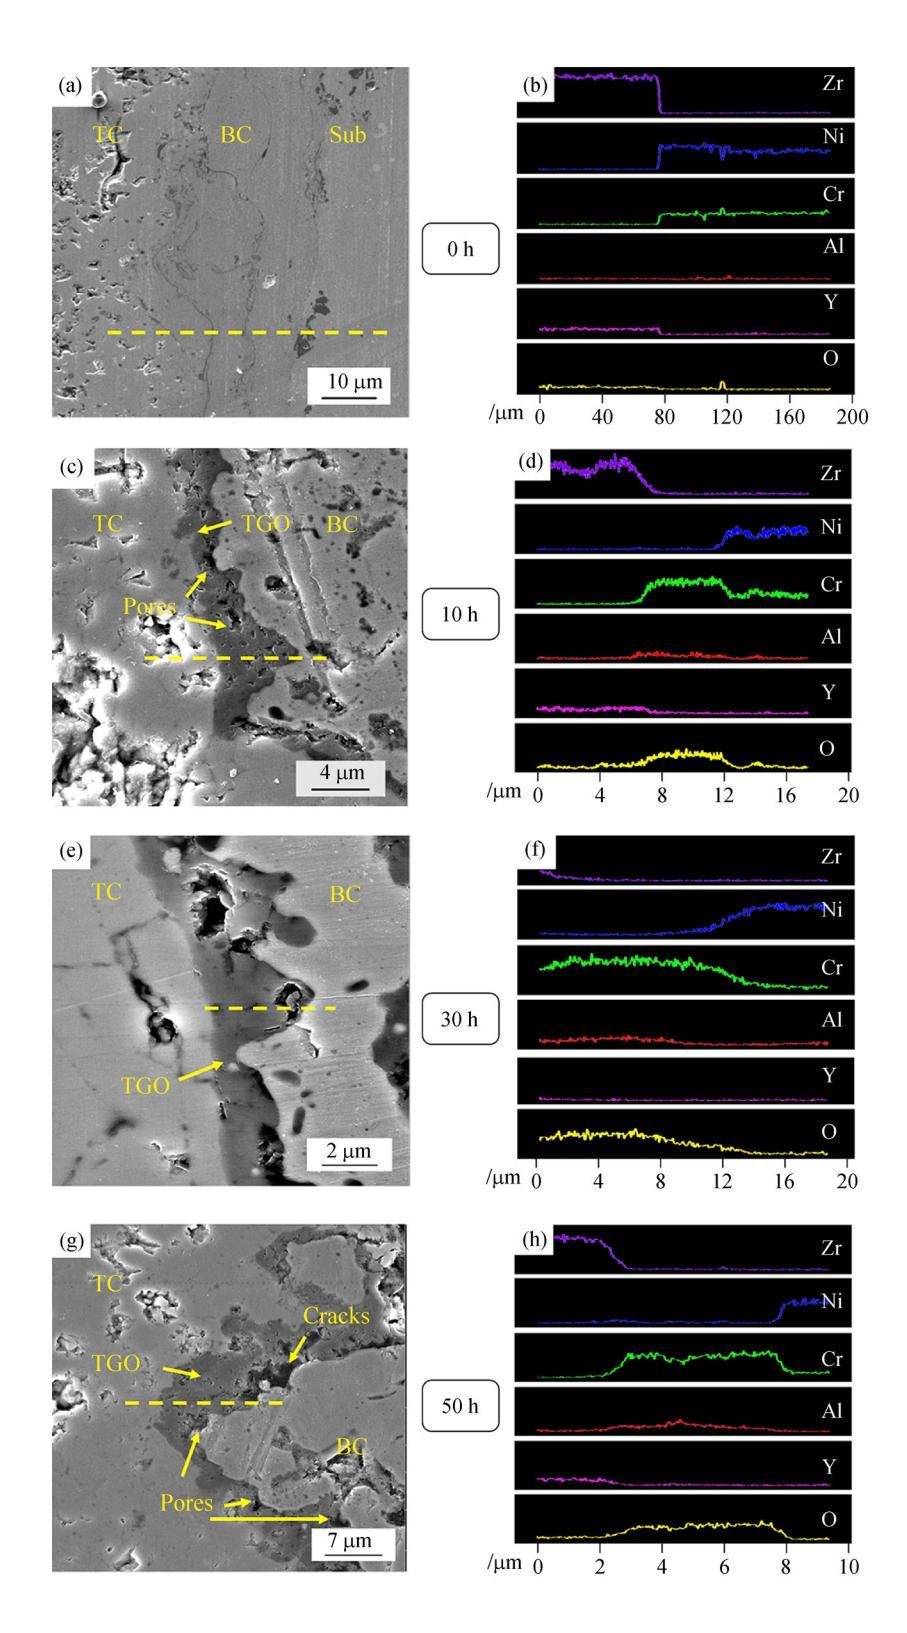
Figures 3(a)-3(h) show the SEM images and energy spectra of the cross sections of TBCs at different oxidation times. Figure 3(a) shows that the oxygen content in the coatings was negligible after spraying, indicating that almost no TGO was generated before high-temperature oxidation. After high-temperature oxidation, a thin, irregular oxide layer appeared at the interface of the ceramic and bonding layers, as shown in Figs. 3(c), 3(e), and 3(g). As the oxidation time increased, the TGO layer gradually thickened in an irregular pattern.

Figures 3(d), 3(f), and 3(h) show that the ratio of Cr to Al was almost the same under increasing oxidation time along the thickness direction of TGO. The same was observed for the ratio of Cr to Al in the initial bonding layer in Fig. 3(b), indicating that Cr and Al simultaneously reacted with O. Although Al and Cr can be oxidized, the Gibbs free energy of Al₂O₃ is larger than that of Cr₂O₃ [7]. Liang et al. [25] showed that the lattice mismatch between Al₂O₃ and the bonding layer is more severe than that between Cr₂O₃ and the bonding layer, and this difference leads to the fact that Cr₂O₃ is likely to grow along the original lattice of the bonding layer. Moreover, the content of Cr in the bonding layer is higher than that of Al. Thus, the content of Cr₂O₃ in TGO is the highest.

Figures 3(c), 3(e), and 3(g) show microscopic pores at the interface of TGO and the bond layer. As the hightemperature oxidation time increased, pore sizes gradually increased, and some even merged to form large pores.

Figures 3(b), 3(d), 3(f), and 3(h) show that the Ni content is large in the bonding layer, and almost no presence of Ni was found in TGO. Suo et al. [26] found that alloying elements of the oxidation interface undergo nonreciprocal diffusion and the Kirkendall effect during the oxidation of the bonding layer. At the interface of TGO and the bonding layer, Al and Cr in the bonding layer

Fig. 3 SEM images and line sweep energy spectra of TGO at different oxidation times: (a, b) before oxidation, (c, d) at 10 h, (e, f) at 30 h, and (g, h) at 50 h

According to the cross-sectional energy spectra of the TBCs at different oxidation times (Fig. 3), the contents of

According to the results of SEM shown in Fig. 3, after the high-temperature oxidation of the TBCs, pores formed at the interface of TGO and the bonding layer, and the number of pores gradually increased as the TGO

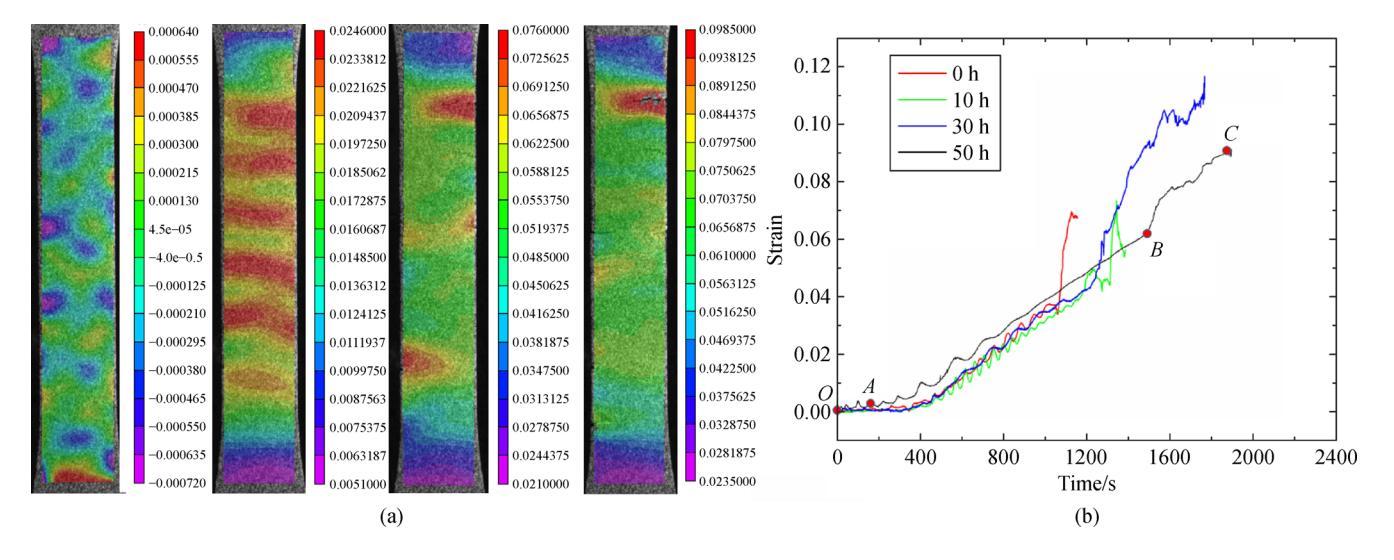
The movements of the coating surface under uniform tensile load were recorded by a CCD camera to derive spot movements on the surface of the coatings. The changes in the surface strain of the coatings until cracking obtained via DIC are shown in Fig. 4. Figure 4(a) shows the strain change curves of the initial cracking location on the coating surface under different oxidation times. The strain image changes shown in Fig. 4(b) are divided into four stages until the initiation of surface cracks:

Figure 4(b) shows the strain curves of the first surface

crack point of the coatings under different oxidation times with the tensile time. The curves follow the four stages. With the strain curve of 50 h oxidation as an example, OAwas the first stage, and the surface strain of the coatings was small at this stage. As the strain increased, the coatings entered the strain fluctuation stage (the AB section). In this stage, the strain showed a fluctuating rising state. After the *B* inflection point, the strain at the cracking point of the coating surface increased sharply until cracks occurred. When the stress on the surface of the coatings exceeded the tensile limit, that is, the strain also increased to a certain value (Point *C*), the surface crack of the coatings initiated and expanded.

Fig. 4 Variation in the surface strain of TBCs under uniform tensile load. (a) Cloud surface strain change with time; (b) strain curves of the coating surface with time

surface cracks after high-temperature oxidation, which is consistent with the finding that the surface crack initiation of the oxidized coatings in Fig. 4 takes longer time than that before oxidation. This finding is also consistent with the result that the occurrence time of the surface crack AE signals after oxidation is later than that before oxidation (Fig. 5).

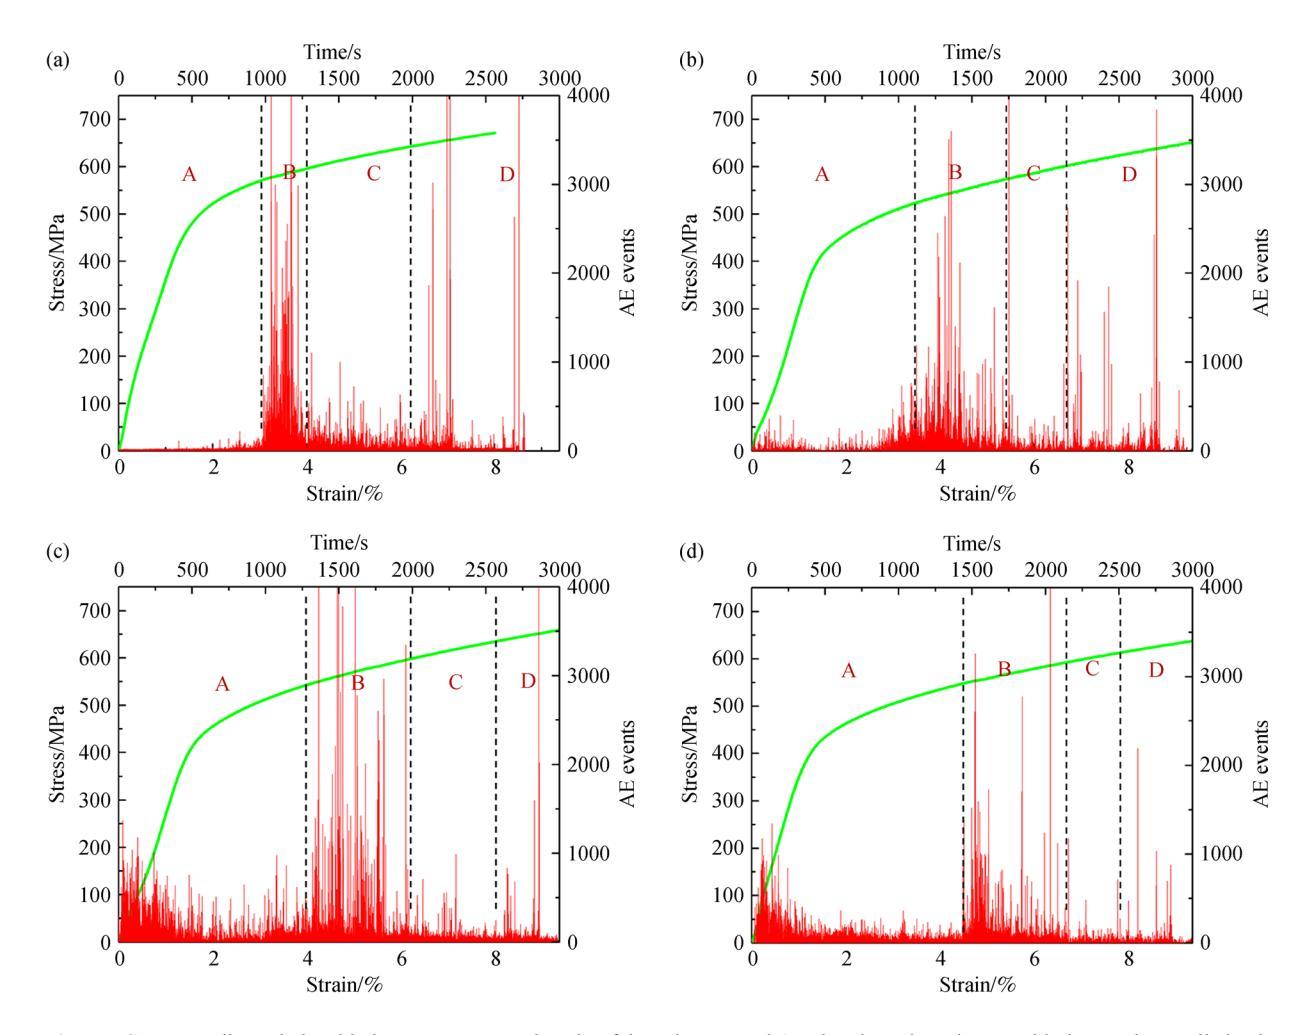
The stress-strain relationship of the substrate during the stretching process and the AE events of the coatings with stretching time are shown in Fig. 5. The AE events during stretching were divided into four stages: A, B, C, and D. A is the elastic deformation stage; B is the surface vertical crack stage; C is the surface crack saturation transition stage; and D is the interface crack stage. Comparison of Fig. 5(a) with Figs. 5(b)-5(d) indicates that before and after the high-temperature oxidation, the TBCs presented a significant difference in AE signal in Stage A. The AE events before the high-temperature oxidation were almost zero in Stage A. However, after the high-temperature oxidation, gradually decaying AE signals were generated as soon as the coatings began to stretch in Stage A. With the increase in oxidation time, the AE events gradually increased in Stage A. The time when surface cracks began to appear was gradually delayed, but the AE events of the interface crack gradually decreased.

Fig. 5 Corresponding relationship between stress and strain of the substrate and AE signals as they change with time under tensile load. (a) 0 h; (b) 10 h; (c) 30 h; (d) 50 h

As the tensile strain increased, the microcracks gradually increased. These microvoids and microcracks contributed to the slow release of the TGO-bonding layer stress and provided a certain strain coordination effect. If no pore exists between the bonding layer and TGO, then the tight bond of the TGO-bonding layer interface can cause the bonding layer load to transfer immediately to TGO or even the ceramic layer. In this case, the strain of the ceramic layer will rapidly increase to the failure limit, which is presented by the surface cracks in Fig. 5(a) where the AE signals start at 1000 s. However, the appearance of micropores and microcracks causes the tensile load on the TGO to be lower than the tensile load on the bonding layer and the substrate, resulting in a delay in surface cracking time. The surface crack initiation time in Figs. 5(b)-5(d) is delayed from 1100 to 1500 s.

As the tensile strain increased, surface cracks also occurred in the coatings after the high-temperature oxidation. However, due to the multiple microcracks in the TGO layer, the AE signal density of the interface crack decreased when the surface cracks spread to the interface, as shown in Fig. 5. Therefore, the microcavity-microcrack structure contributed to the cooperation of the coatings to some extent and delayed the occurrence of failure.

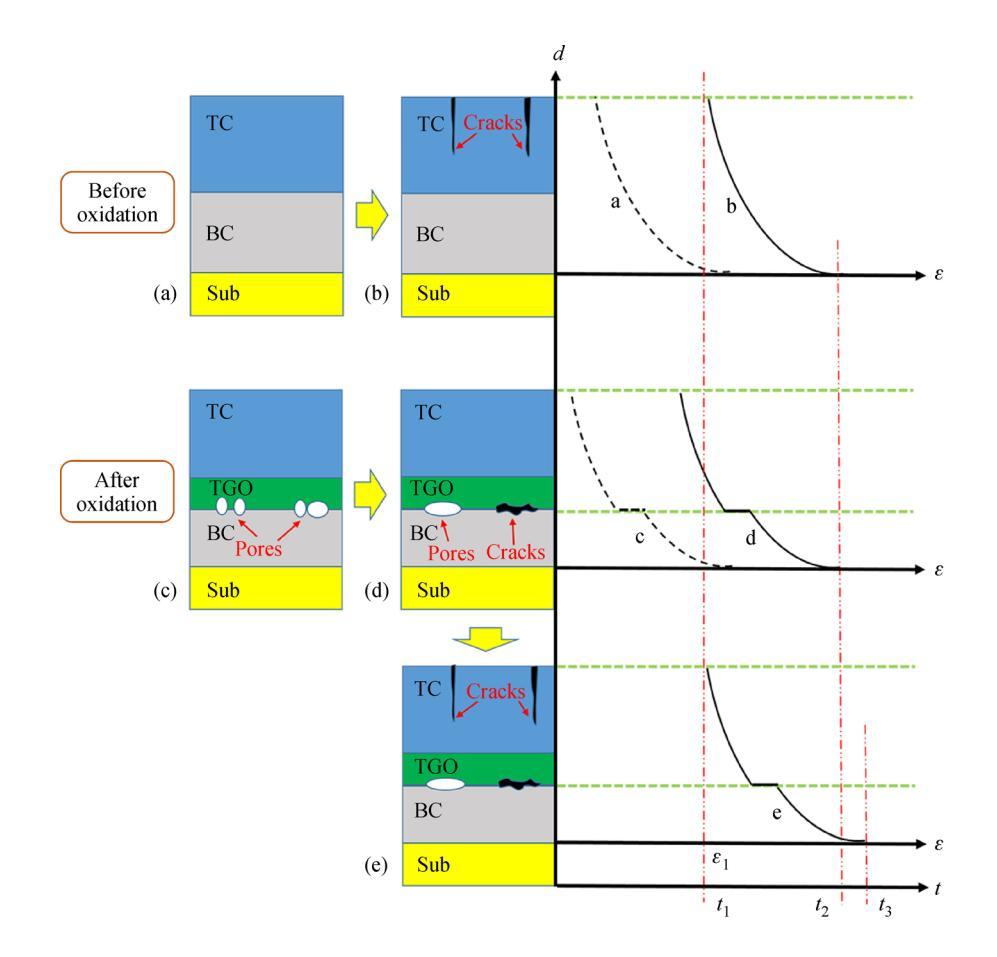
Figure 6 is a schematic showing the effect of pores on the strain change of the TBCs before and after oxidation. Lines a–e in the coordinate axis correspond to the strain of images Figs. 6(a)–6(e) at a certain moment. Figure 6 also shows the ratio of strain to the time at which the uniform rate static tensile substrate is kept constant. Before oxidation, TGO was not contained in the coating, and the strain applied to the substrate was transmitted to the ceramic layer along a certain regularity and gradually increased with the increase in stretching time. When the surface strain of the ceramic layer reached ε_1 , surface cracks appeared at the ceramic layers, as shown in Figs. 6(a) and 6(b). This process also corresponds to the phenomenon of the AE signals' disappearance in the coatings before the appearance of surface cracks in Fig. 5(a). After oxidation, TGO formed at the interface between the ceramic and bonding layers. Many pores appeared at the interface between TGO and the bonding layer. During the static tensile process, the pores merged with one another to form large pores or microcracks. These microcracks and microvoids contributed to stress relaxation and provided strain coordination, which reduced the rate at which the interface of the bonding layer transferred strain to TGO. Therefore, the strain at the TGO and ceramic layer was lower than that at the ceramic layer before oxidation. As shown in Figs. 6(c) and 6(d), the strain at the ceramic layer and TGO was partially delayed compared with that before oxidation. Comparison of Figs. 6(b) and 6(d) shows that although they all occurred at time t_2 , the surface crack in Fig. 6(b) already initiated. However, the strain on the surface in Fig. 6(d) was still lower than ε_1 . Surface cracks did not appear due to the strain delay, indicating that the TBCs before high-temperature oxidation were prone to surface cracks. As stretching time continued to increase, the strain on the surface of the coatings after oxidation reached ε_1 until time t_3 . This result indicates that the pores at the interface between TGO and the bonding layer postponed the time of the appearance of

Fig. 6 Schematic of the influence of pores at the interface of TGO and the bonding layer on TBCs under tensile load
